**Ministry of Agriculture, Forestry and Water Management**  
**Second Institutional Development and Agriculture Strengthening**  
**Project (MIDAS 2)**

**MNE-MIDAS2-8820-ME-IC-CS-23-3.17**

**Technical assessment of the fishing vessel trawler (TO) and purse  
seiners (SP)**

**VESSEL REPORT**

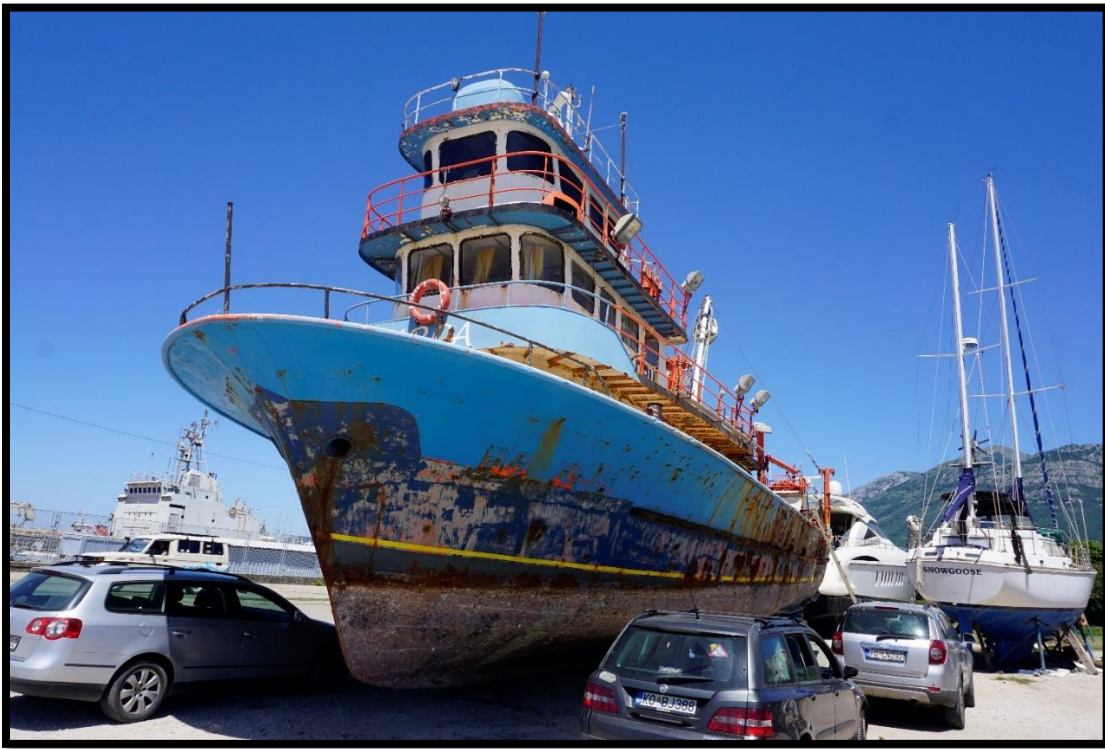
## 1. F/V ARCA

The overall condition of this fishing vessel is poor.

It is very difficult to estimate the amount of investment that would be needed to reconstruct the vessel, as a deeper analysis of the hull and equipment failures is required.

A very experienced shipyard, which has been work on this and similar vessel for many years, is needed for the needs of reconstruction and defects repair.

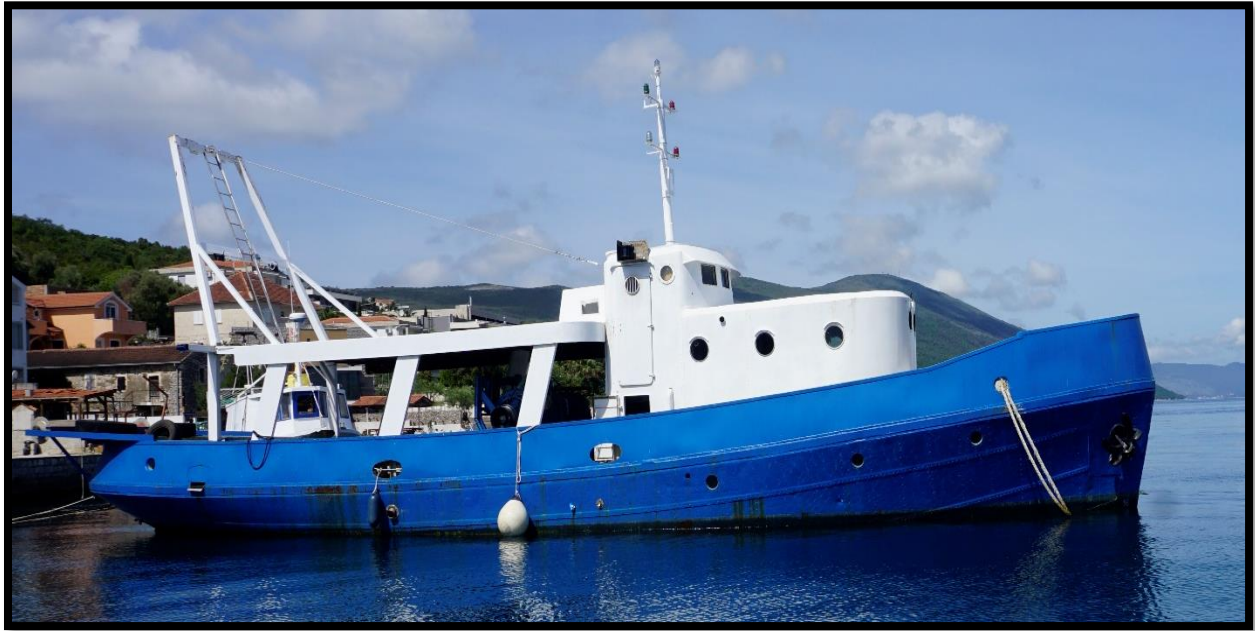
## 2. F/V ARSENAL II

The condition of the hull plating is good.

The condition of the deck is similar to the condition of the hull plating.

The overall condition of this fishing vessel is satisfactory.

A rough estimate of those investments would be around 30,000 euros.

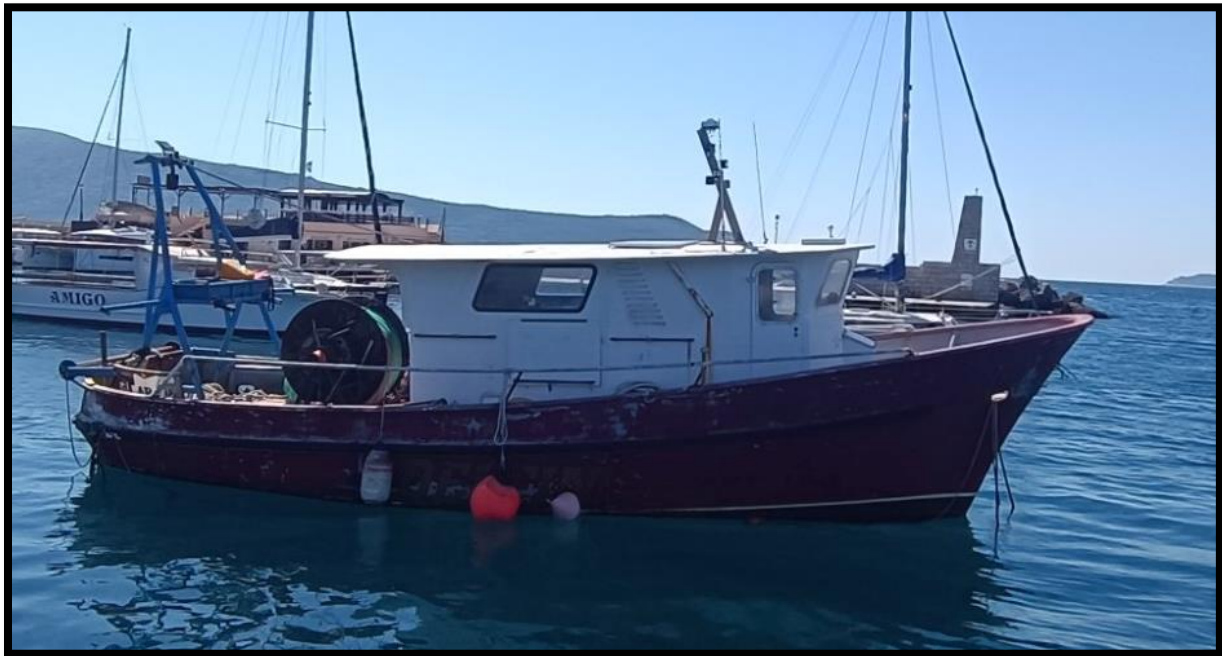
### 3. F/B ČALE 2

The condition of the hull is good, there are no signs of water leaking into the hull.

The steering gear is hydraulic and currently is not functional. It needs to be replaced with a new one. The price is 2,500 euros.

The overall condition of this fishing vessel is satisfactory. It does not take a lot of money to make the vessel safe for fishing, except for the investment in a new inboard engine.

It is necessary to replace the existing hand rail and install a new one made of chrome, the price would be around 2,500 euros.

Although the engine is functional, its age and difficulty in finding replacement parts make it necessary to replace with a modern engine of similar power. An inboard heavy duty diesel marine engine of similar power (about 230 hp), with a hydraulic clutch, shaft line, stuffing box and propeller would cost about 40,000 euros.

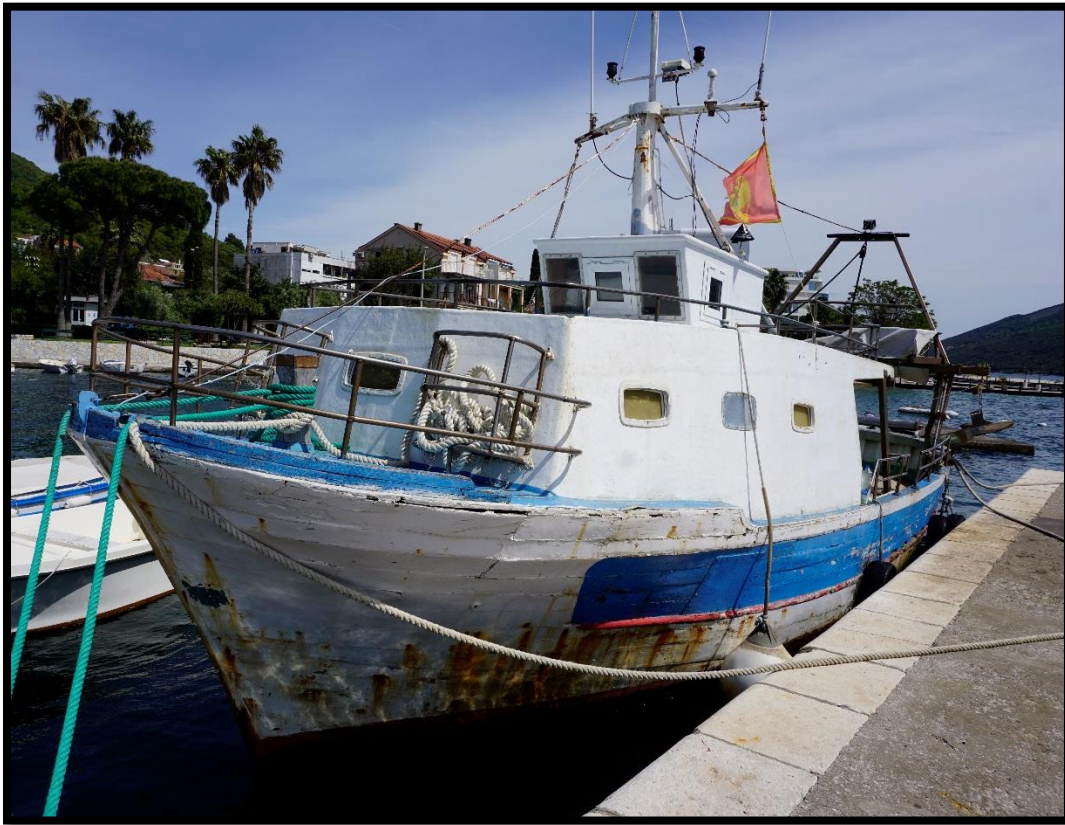
#### 4. F/B CATERINA

The condition of the hull is not good, there are clear indications of water leakage into the hull, but a detailed inspection of the condition of the hull is required when the vessel is landed.

There are indications of loosening of some parts of the hull, where corrosion of the rivets (nails) is visible.

The condition of the deck is similar to the condition of the hull plating.

The fuel tanks are in bad condition, corroded and their replacement with new stainless steel tanks of the same volume is around 8,000 euros. The fuel line is functional. Since the main engine is very old, it would be necessary to install a suitable new marine diesel engine (Heavy Duty Diesel Inboard Engine) of suitable power, such as the existing one (about 130 KW).

Those positions should be inspected separately, nailed with new galvanized nails, if the frames on the inside are good, and if they are not, replace the bad frames, and only then nail the planks.

The conclusion is that there will be serious work on the hull and deck plating and the owner intends to replace 70 percent of the hull plating, frames and almost the entire deck. That repairing can be worth about 60,000 euros.
