INDEPENDENT ENGINEER

MONTHLY REPORT MARCH 2023

Contract number: 8847

MONTHLY REPORT

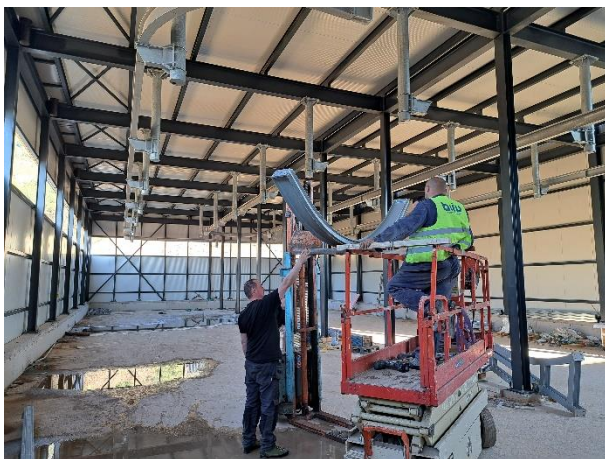
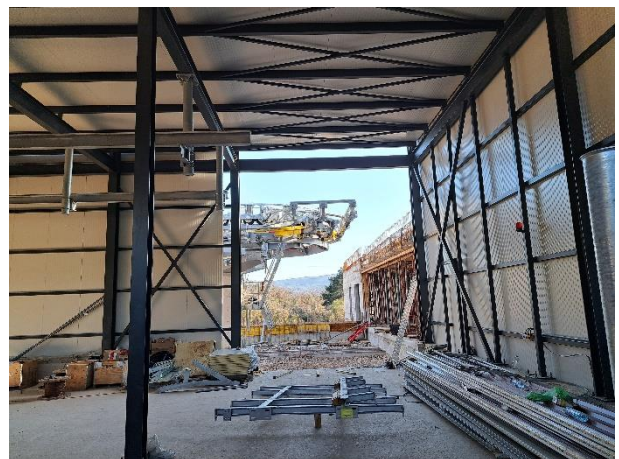
Figure 10-2: Gondola parking

- For the works in the scope of the Authority (grantor), no time schedule has been submitted as so far. Serious delays may be expected.
- The ropeway's grounding system issues have not been resolved as so far.
- Design of the gondola parking building and LEITNER's automatic garage are not in full compliance. Additional girders have to be installed.

- To avoid further problems and delays with construction of the gondola parking, the modified Design (i.e. the one that includes the missing girders) shall also be checked separately by LEITNER. Designer is obliged to provide missing details asap.
