INDEPENDENT ENGINEER SUPERVISION OF WORKS

WEEKLY REPORT CW 05

Contract number: 8854

OVERVIEW OF THE CIVIL WORKS AND THE ASSEMBLY PROGRESS ON THE GONDOLA LIFT

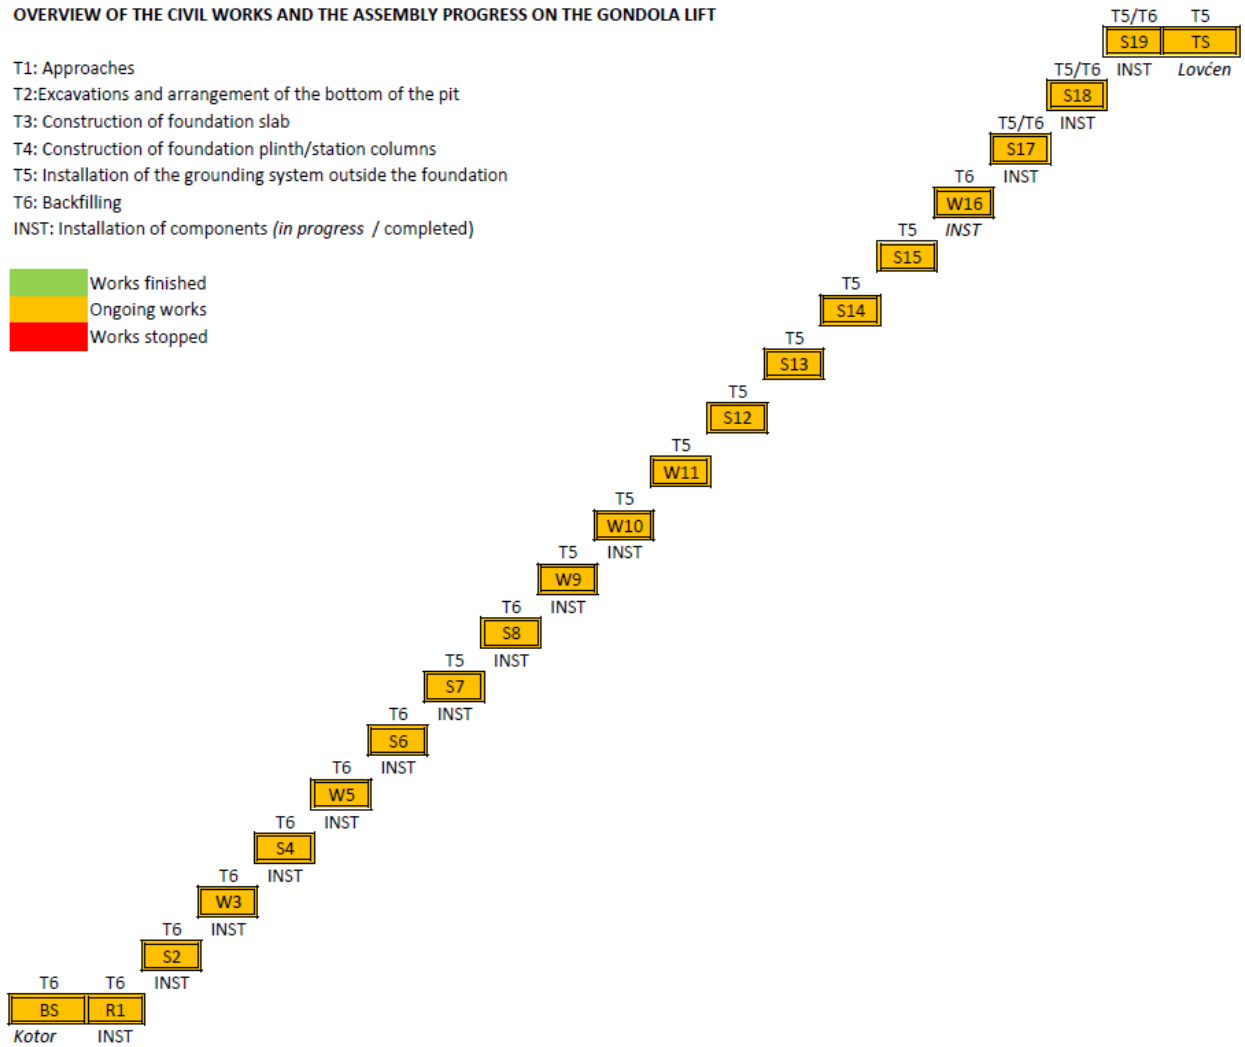
- T1: Approaches
- T2: Excavations and arrangement of the bottom of the pit
- T3: Construction of foundation slab
- T4: Construction of foundation plinth/station columns
- T5: Installation of the grounding system outside the foundation
- T6: Backfilling
- INST: Installation of components (*in progress / completed*)

- Works finished
- Ongoing works
- Works stopped
