INDEPENDENT ENGINEER SUPERVISION OF WORKS

WEEKLY REPORT CW 06

Contract number: 8854

This document is issued on basis of the Independent Engineer Services contract signed between IPSA Institute, Government of Montenegro and Žičara Kotor - Lovćen Ltd. Podgorica, number 8854 (IPSA Institute), as a report on monitoring and supervision of works on construction of the Kotor – Lovćen Ropeway, on weekly level.

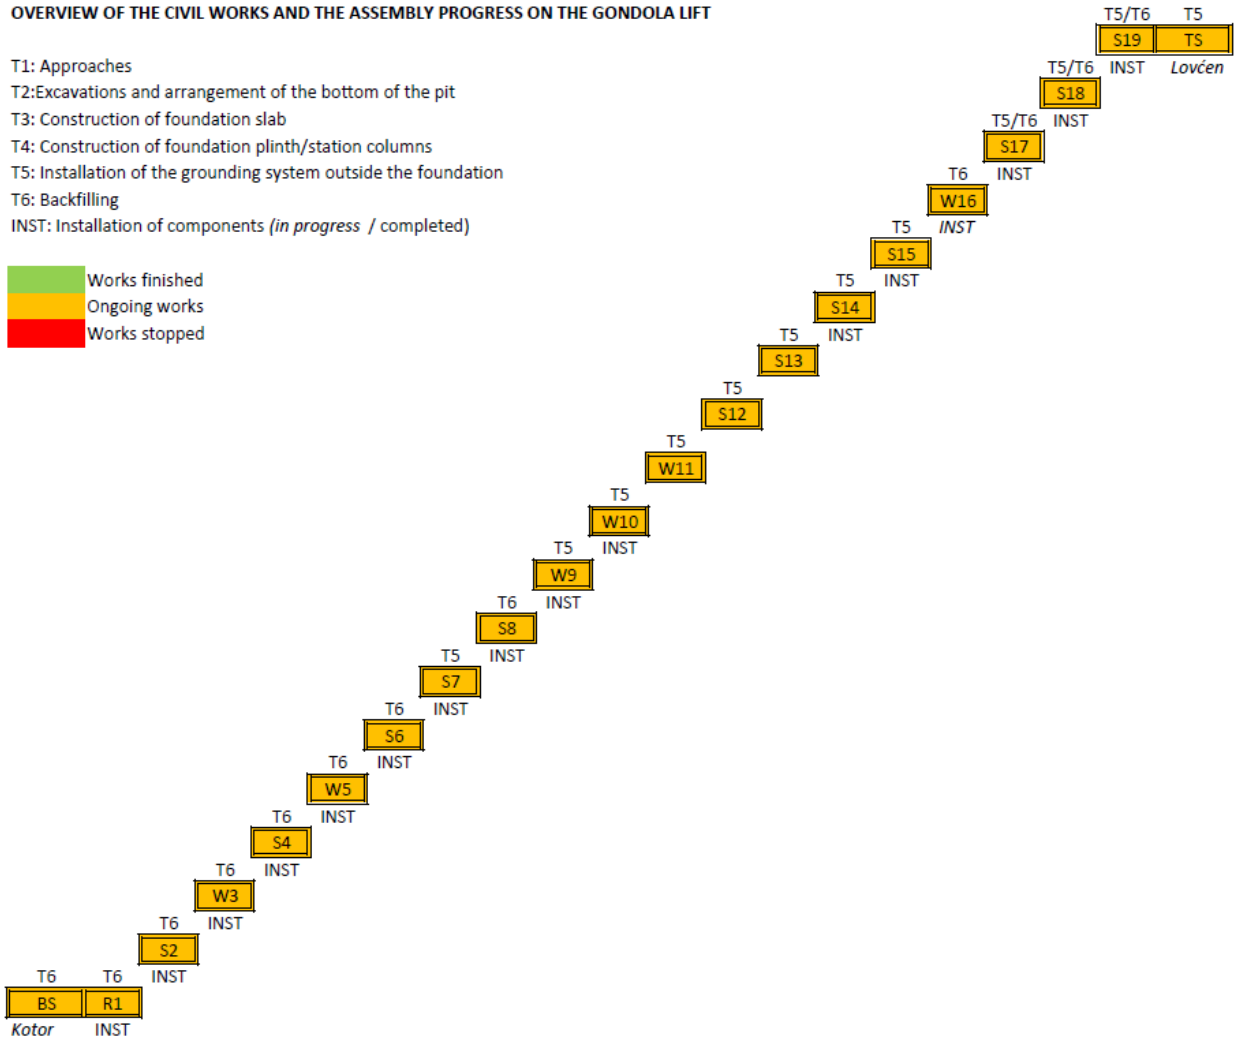
OVERVIEW OF THE CIVIL WORKS AND THE ASSEMBLY PROGRESS ON THE GONDOLA LIFT

- T1: Approaches
- T2: Excavations and arrangement of the bottom of the pit
- T3: Construction of foundation slab
- T4: Construction of foundation plinth/station columns
- T5: Installation of the grounding system outside the foundation
- T6: Backfilling
- INST: Installation of components (*in progress / completed*)

- Works finished
- Ongoing works
- Works stopped
