JOHN ALDRIDGE
CONSULTANCY

Tivat to Jaz Beach Road, Montenegro
Results of Traffic and Pedestrian Counts completed 18th – 21st
November 2020

Project Title	Tivat, to Jaz Beach, Montenegro
	Traffic & Pedestrian Counts
Report Title	Results of Pedestrian and Traffic Counts completed 18 th to 21 st November 2020
	Reference: jma/00029/002
Revision	002
Status	Draft
Control Date	10/12/2020

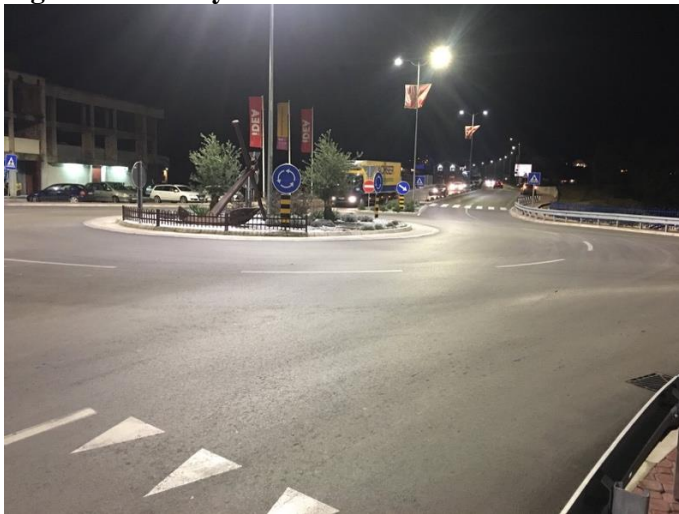
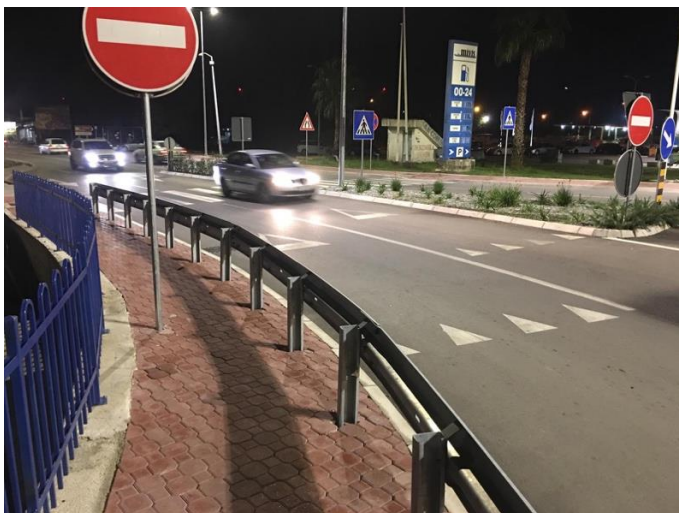
Figure 2.1: Newly constructed roundabout near the survey location

At site 1 the road alignment has changed from the conditions shown on Google Street View. The conditions on site now include a newly constructed roundabout as shown in the images in Figure 2.1 below. The new roundabout serves cargo and official access to the airport and is located just north of the survey site.

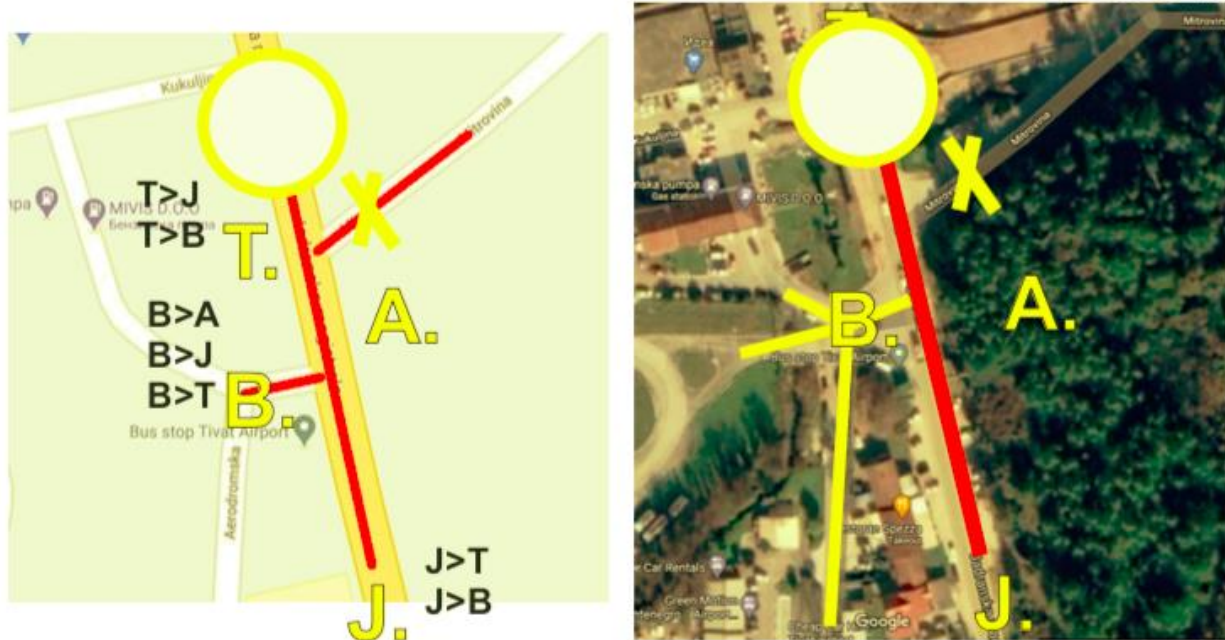
Figure 2.2: Traffic and pedestrian count locations. New roundabout location shown.

The survey site location has recorded turning movements into and out of the airport at location B as shown below in figure 2.2. Movements to the minor road (Mitrovina) at location A, were not recorded as part of the survey as this road has been temporarily closed with sandbags.

Due to the newly constructed roundabout close to the airport, which appears to be an additional roundabout to the one proposed in the submitted drawings for Road Safety Audit, it is unclear if there is likely to be a change to access arrangements to the airport following the completion of the Tivat to Jaz Beach Road upgrade to account for the additional new roundabout. As this is unknown, the survey results

are based upon the information and drawings as presented within the initial Road Safety Audit. The survey has therefore recorded the main traffic movements on the Tivat to Jaz Beach Road as well as turning movements into and out of Road B which serves the airport.

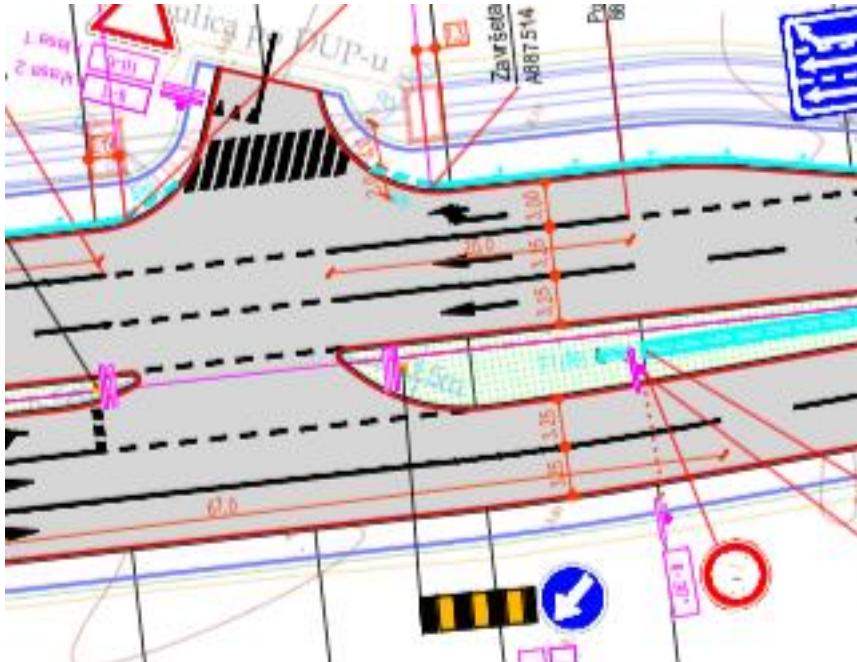
Figure 3.3: Extract from the Road Safety Audit Report outlining comments raised by Audit Team and Design Team.

Previous report Ref	Safety Problem	Recommendations	Ranking H/M/L	Cost in €	Accept/Decline	Designers Response	Audit Response
5	<p>At km. 887+503 a break in the median is proposed and left turn junction is introduced. The introduction of a break in the median to enable turning movements introduces a potential conflict between high speed through traffic and low speed turning vehicles to the detriment of road safety.</p>

<p>It is recommended that the break in the median is removed and instead the junction is made a right in/right out arrangement only with left turn movements instead completed through the nearby roundabouts.</p>	HIGH	<p>The changes are likely to reduce project costs.</p>		<p>We consider that you are right, but the positions of the intersections are designed in accordance with the valid planning documentation.</p>	<p>Road safety concern still remains, although it is accepted that changes may be difficult to achieve if the design is in accordance with planning documentation.</p>

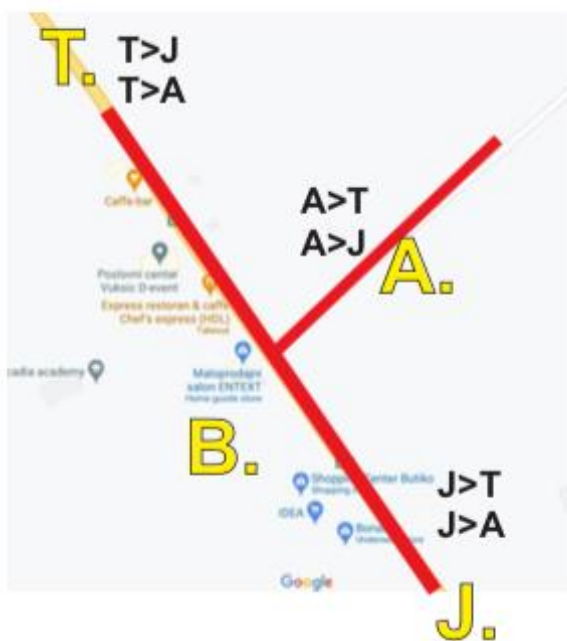
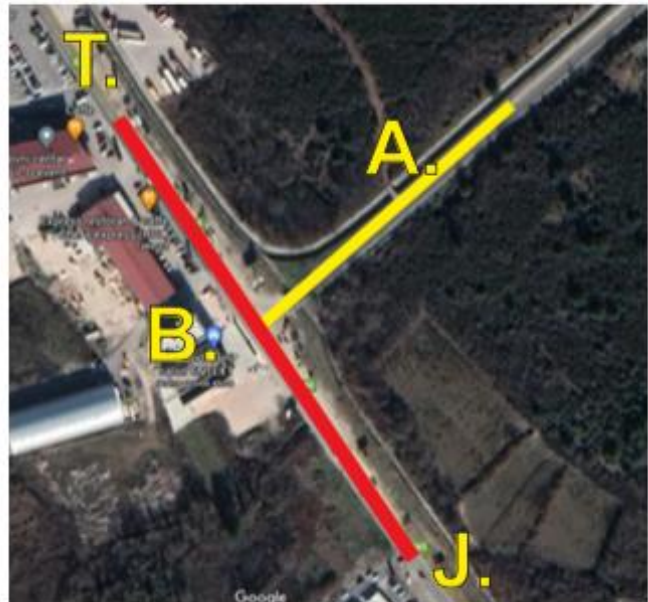
Figure 4.1: Observed directions of movement for counts of pedestrians and traffic at Site 3.

Observed pedestrians crossing during the survey at the location of the proposed pedestrian crossing were low. A total of 27 pedestrian crossing movements were recorded over the 4 days. The highest number of pedestrian activity on any day was 9 pedestrian movements, and this number was recorded on both the Thursday and Friday. The majority of the pedestrian crossing movements occurred in the direction from the minor road labelled A, towards the commercial buildings labelled as B in Figure 4.1. There were no noticeable peak in pedestrian activity, instead there were low number of movements throughout the day.

Based on the road safety concerns raised within the Road Safety Audit report a traffic signal controlled pedestrian crossing was recommended at this location. The conducted pedestrian count survey has recorded a low number of pedestrian activity at this location. These figures may be lower than usual due to Covid-19 and accounting for the low season, as flows may be higher in the summer.

Although the pedestrian flows recorded are low, the upgraded road still results in the introduction of multiple lanes of traffic. In addition, vehicle flows are relatively high (recorded AADT at this site location was 15,498 on day 3 of the survey) and double during the summer months. This makes it a challenging and dangerous environment for pedestrians to cross. Therefore the introduction of a push button traffic signal operated crossing is still recommended at this location.

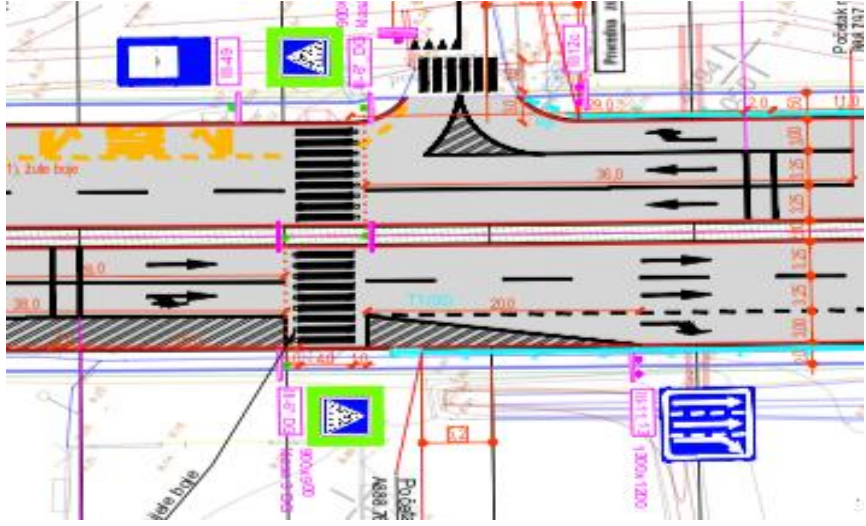
Figure 4.3: Extract from the Road Safety Audit report

<p>10</p>	<p>An uncontrolled pedestrian crossing is proposed at km 888+755. A pedestrian crossing over a multiple lane highway where speeds are likely to be high (although posted as low speed), and where there is an additional danger of a vehicle stopping in one lane, but not the other lane, puts pedestrians at an increased risk of being struck by passing vehicles.</p> <p>It is further noted on the west side of the carriageway that the hatched road markings may provide an unclear message to road users. Pedestrians may stand in the area as they consider it a sheltered area to wait to cross, whilst the area may also be driven over by motorists who drive over the hatched area to make the right turn lane ahead. This ambiguity may lead to positive increased likelihood of conflict between pedestrians and motorists.</p>

<p>It is recommended that grade separated pedestrian crossings (bridges) are introduced on multiple lane roads where vehicle speeds are expected to be high. Alternatively, a push button signalised pedestrian crossing is introduced. Rumble strips are not likely to obtain the required speed reduction.</p>	<p>HIGH</p>	<p>Bridge EUR 100k. Signalised push button pedestrian crossing EUR 30k.</p>	<p>It is not accepted.</p>	<p>The traffic lights at the intersection, as well as the foot-bridge project, were not the topic of the projected task, therefore, it is not even considered at the level of the design solution. If the Investor deems it necessary to do so, this should be the subject of a separate project.</p>	<p>The road safety concern remains. The higher cost for an appropriate solution may be justified in terms of road safety. The justification for the pedestrian crossing type is usually determined by the number of pedestrian movements and vehicle speeds and volumes. This information is not available to the RSA Team.</p>

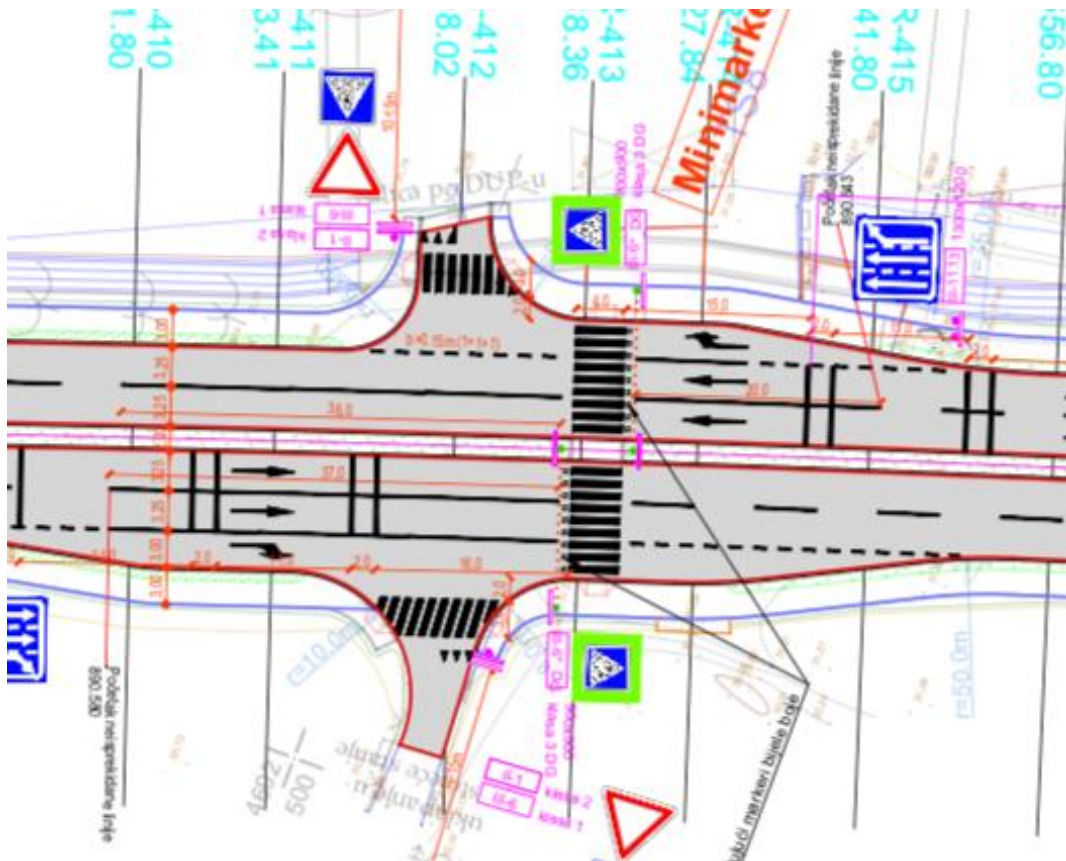
Figure 5.2: Proposed uncontrolled pedestrian crossing over multiple traffic lanes at Site 4.

The road safety audit report completed for the Tivat to Jaz Beach Road raised concerns about the proposed uncontrolled pedestrian crossing at this site location across multiple lanes of traffic as shown in the drawing extract in figure 5.2. The survey has therefore counted pedestrian movements at the location for 4 days from 0600 – 1800hrs on each day to ascertain pedestrian demand and to help determine what sort of crossing is appropriate for pedestrians at this location.

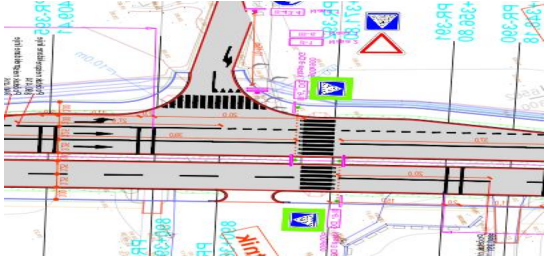
Figure 5.3: Extract from the Road Safety Audit report

<p>13</p>	<p>An uncontrolled pedestrian crossing is proposed at km 890+386. & km 890+618. Pedestrian crossings over a multiple lane highway where speeds are likely to be high (although posted as low speed), and where there is an additional danger of a vehicle stopping in one lane, but not the other lane, put pedestrians at an increased risk of being struck by passing vehicles.</p>

<p>It is recommended that grade separated pedestrian crossings (bridges) are introduced on multiple lane roads where vehicle speeds are expected to be high and breaks in the traffic are limited, especially during peak summer flows. Alternatively a push button pedestrian crossing is introduced.</p>	<p>HIGH</p>	<p>Bridge EUR 100k. Signalised pedestrian push button crossing EUR 30k.</p>	<p>It is not accepted.</p>	<p>The traffic lights at the intersection, as well as the foot-bridge project, were not the topic of the projected task, therefore, it is not even considered at the level of the design solution. If the Investor deems it necessary to do so, this should be the subject of a separate project.</p>	<p>The road safety concern remains. The higher cost for an appropriate solution may be justified in terms of road safety. The justification for the pedestrian crossing type is usually determined by the number of pedestrian movements and vehicle speeds and volumes. This information is not available.</p>

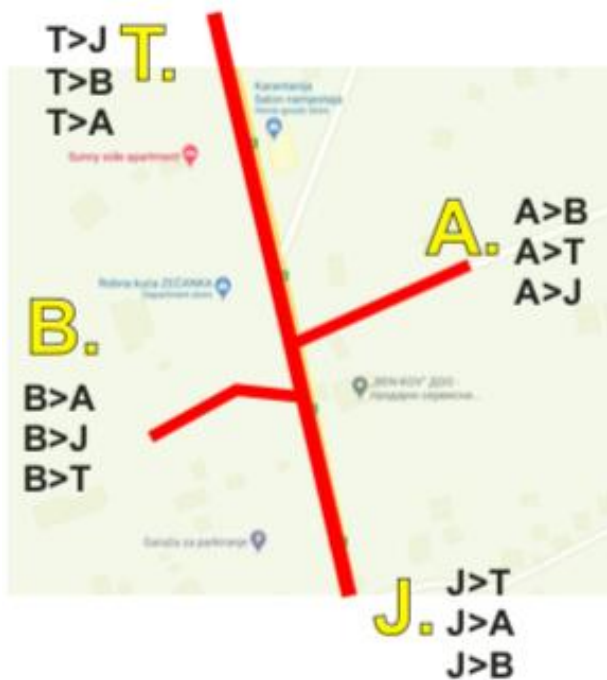
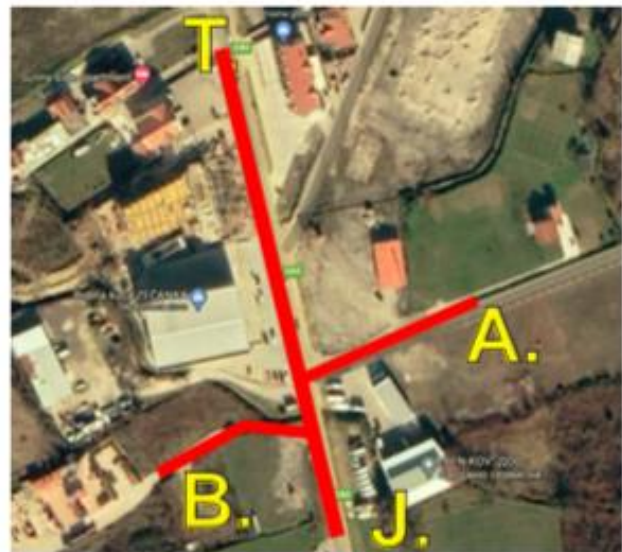
Figure 6.1: Observed directions of movement for counts of pedestrians and traffic at Site 5.

Pedestrian activity at the location of the proposed pedestrian crossing were recorded as 201 pedestrians over the 4 days of surveys. The highest number of pedestrian activity on any day was 57 pedestrian movements recorded on the Friday. There were 49 pedestrian movements recorded on the Saturday, 45 on Wednesday and 50 on Thursday. Therefore pedestrian activity remained fairly consistent each day of the surveys.

There were 374 vehicles recorded over the four days turning from local road A towards Jaz Beach. The turning flows were fairly balanced throughout the survey period it was noted however, that HGVs make this turning movement with 20 HGVs turning on Wednesday, 21 Thursday, 26 Friday and 19 on Saturday. These larger turning vehicles have a potential impact on the junction capacity and safety.

As previously noted, the highest turning left movement was from Tivat into local road A with 1,020 movements. These turning movements were recorded throughout the day with no noticeable peak period. There were however, also HGVs recorded on each day, Wednesday 37, Thursday 27, Friday 48, Saturday 25. These larger vehicles have a potential impact on capacity.

The previously completed Road Safety Audit report recommended that the proposed gap in the median was replaced with a roundabout. Based on the results from the survey this remains the recommended solution. However, as the design team has stated this would not be possible due to land appropriation, the introduction of a traffic signalised junction could be considered as an alternative arrangement together with facilities to provide a pedestrian phase to enable safe pedestrian crossing.

In the absence of a roundabout or a signalised crossing, the next alternative would be to close the gap in the median and to expect vehicles to U turn at the nearby roundabouts at km 889+500 approximately to the north, or km 891+950 to the south. As turning movements are relatively high at survey site 5, it is recommended that additional turning movements which will be displaced to the neighbouring roundabouts should be modelled to ensure that the displaced movements do not exceed the operational capacity of the roundabouts at these nearby locations. If the gap in the median is closed at Site 5, it is still recommended that a pedestrian crossing facility is provided at this location. A signalised pedestrian crossing activated by a push button would be appropriate.

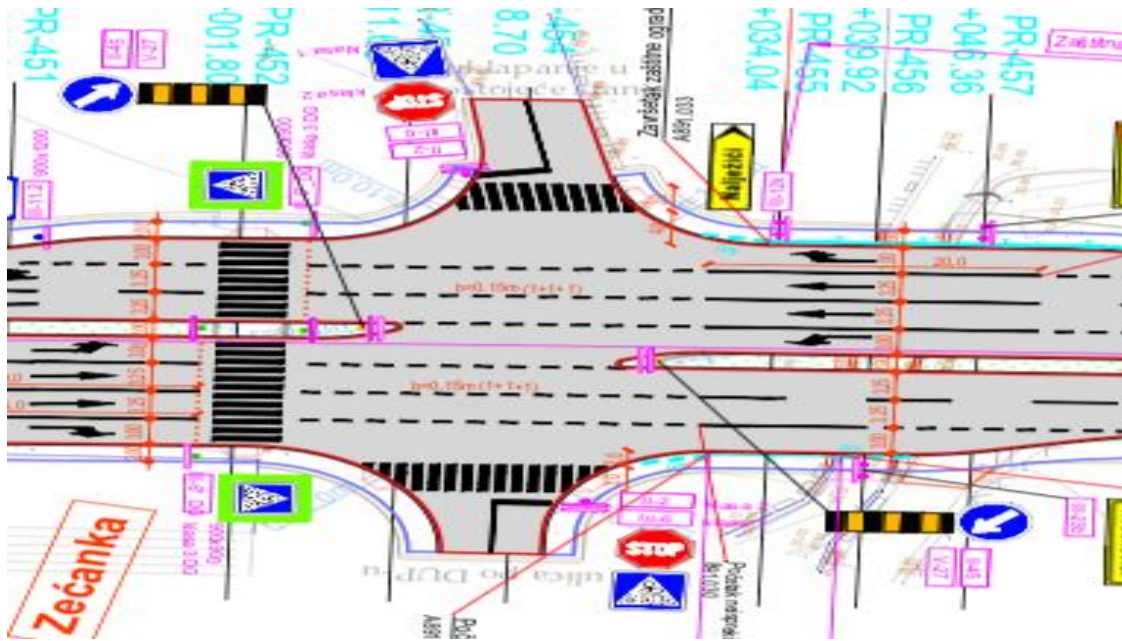
Figure 6.2: Proposed uncontrolled pedestrian crossing over multiple traffic lanes and crossroad junction at Site 5.

The road safety audit report completed for the Tivat to Jaz Beach Road raised concerns about the proposed crossroad at this location as these types of junctions have a poor crash record. It was therefore recommended that a roundabout or traffic signal junction is introduced in place of the proposed gap in the median. There was also a concern raised regarding the uncontrolled pedestrian crossing across multiple lanes of traffic as shown in the drawing extract in figure 6.2. The survey has therefore counted pedestrian

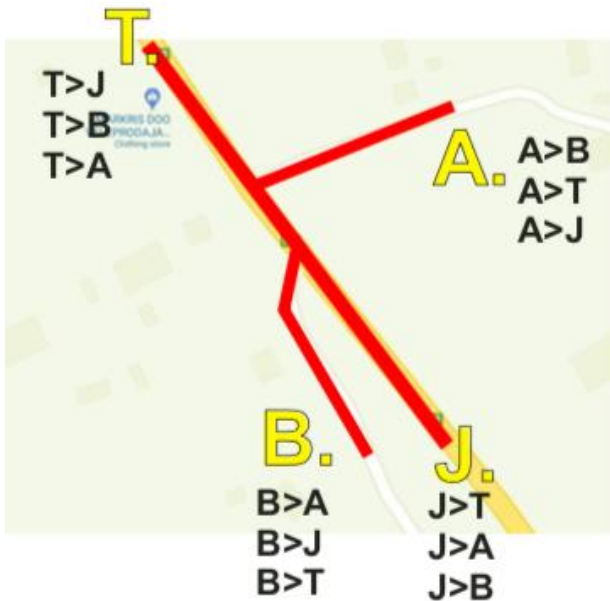
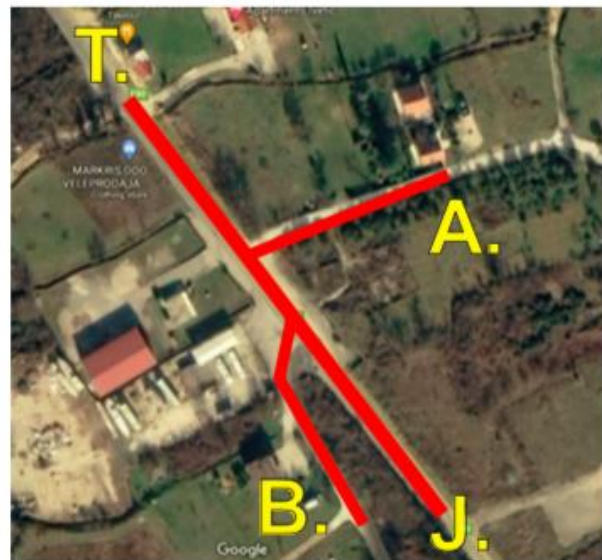
Figure 7.1: Observed directions of movement for counts of pedestrians and traffic at Site 6.

Pedestrian activity at the location of the proposed pedestrian crossing were recorded as 11 pedestrians over the 4 days of surveys. The highest number of pedestrian activity on any day was 5 pedestrian movements recorded on the Friday. Three of the pedestrian movements out of a total of 11 did not cross the road, instead the pedestrians were recorded walking along the Jaz Beach to Tivat road. With low pedestrian flows observed, there is no defined peak of activity.

Based on the road safety concerns raised within the Road Safety Audit report a traffic signal controlled pedestrian crossing (or pedestrian bridge) was recommended at this location. The conducted pedestrian count survey has recorded a total of 11 pedestrian crossing movements at this location over the 4 days with 5 pedestrians recorded on the Friday. These figures may be lower than usual due to Covid-19 and accounting for the low season, as flows may be higher in the summer.

As there appears to be a low pedestrian demand at this location a pedestrian bridge is not justified. However, it is still recommended that a facility for safe pedestrian crossing movements should be provided. The proposed works on the project road result in the widening of the road to multiple lanes in each direction with a median. This creates a more challenging crossing environment for pedestrians as well as potentially higher speeds. Therefore the introduction of a push button traffic signal operated crossing is still recommended at this location. If funds are low to provide such a facility and only limited numbers of signalised crossing could be provided, this would be considered a lower priority site.

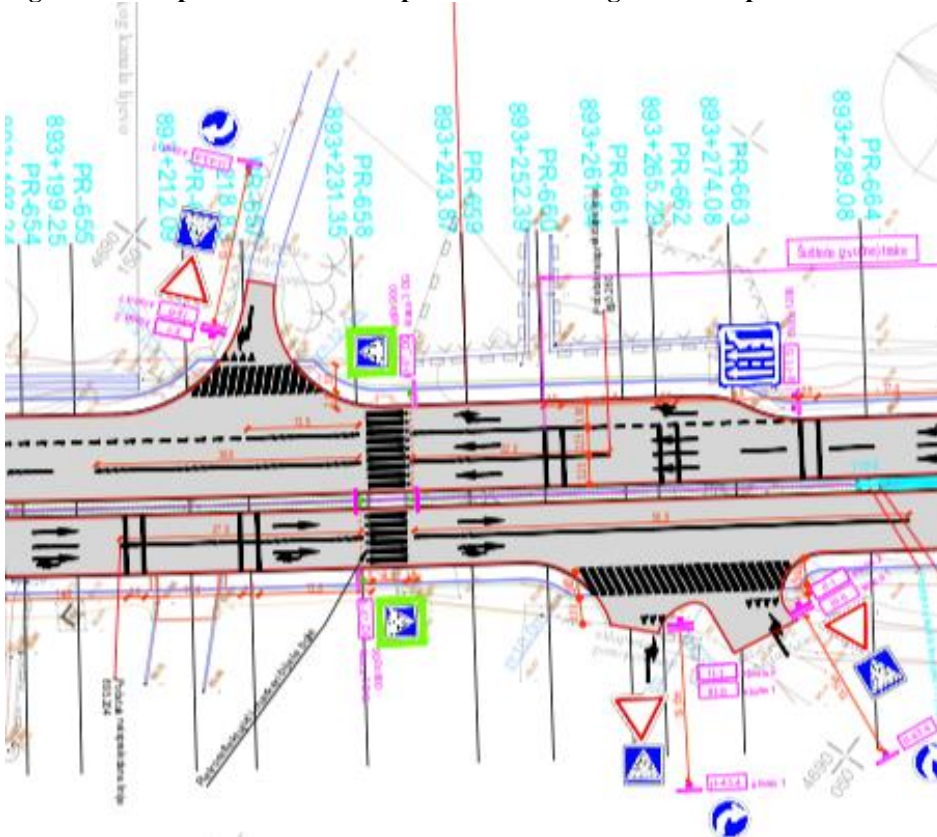
Figure 7.2: Proposed uncontrolled pedestrian crossing over multiple traffic lanes

As survey cameras were being installed at this location, turning counts for vehicles have also been completed to determine vehicle movements in each of the different directions as outlined in figure 7.1. Concerns with vehicle turning movements was not raised as a road safety concern in the Road Safety Audit report (see Figure 7.3) at this location, as there is no break in the median at this location and therefore vehicles wishing to turn will instead utilise the proposed nearby roundabouts. Nevertheless, it is still useful to understand turning demand to ensure closed turning movement does not displace excessive amounts of traffic.

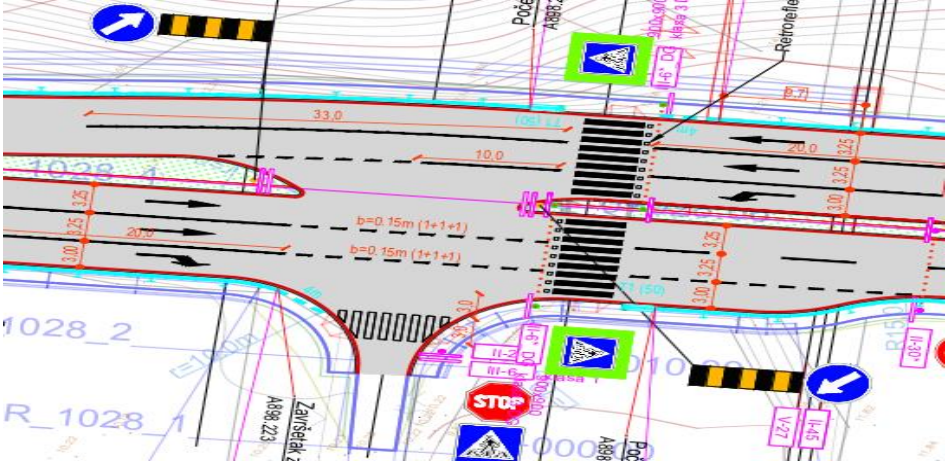
Figure 8.3: Extract from the Road Safety Audit report

<p>30</p>	<p>At km 898+231 there is a proposed break in the median to permit left turn movements, in addition there is a proposed at grade uncontrolled pedestrian crossing over 6 lanes of traffic. At grade crossings for traffic and pedestrians on multiple lane roads increase the risk of conflicts as generally through traffic is travelling at higher speeds due to the design nature of the road and the likelihood of turning vehicles and crossing pedestrians is less likely to be expected.</p>

<p>The drawing shows a road layout with a central median break. It includes lane widths (e.g., 3.00, 3.75, 1.25, 10.0, 20.0, 33.0), pedestrian crossing markings, and various traffic signs such as 'STOP', 'Yield', and 'One-way'. Labels include 'Početak A888', 'Retrometije', 'Završetak A888', and 'R_1028_1'.</p>	<p>It is recommended that the junction design is replaced with a roundabout, this also provides a slower speed for crossing pedestrians. Alternatively the median gap is closed and signalised pedestrian crossing or pedestrian bridge is introduced.</p>	<p>HIGH</p>	<p>Roundabout estimated at EUR 50k >. Pedestrian bridge EUR 100k and signalised pedestrian crossing EUR 30k.</p>	<p>It is not accepted.</p>	<p>The traffic lights at the intersection, as well as the foot-bridge project, were not the topic of the projected task, therefore, it is not even considered at the level of the design solution. If the Investor deems it necessary to do so, this should be the subject of a separate project. At this location, the planned documentation does not provide a roundabout, and at a distance of 400 m there is a projected roundabout.</p>

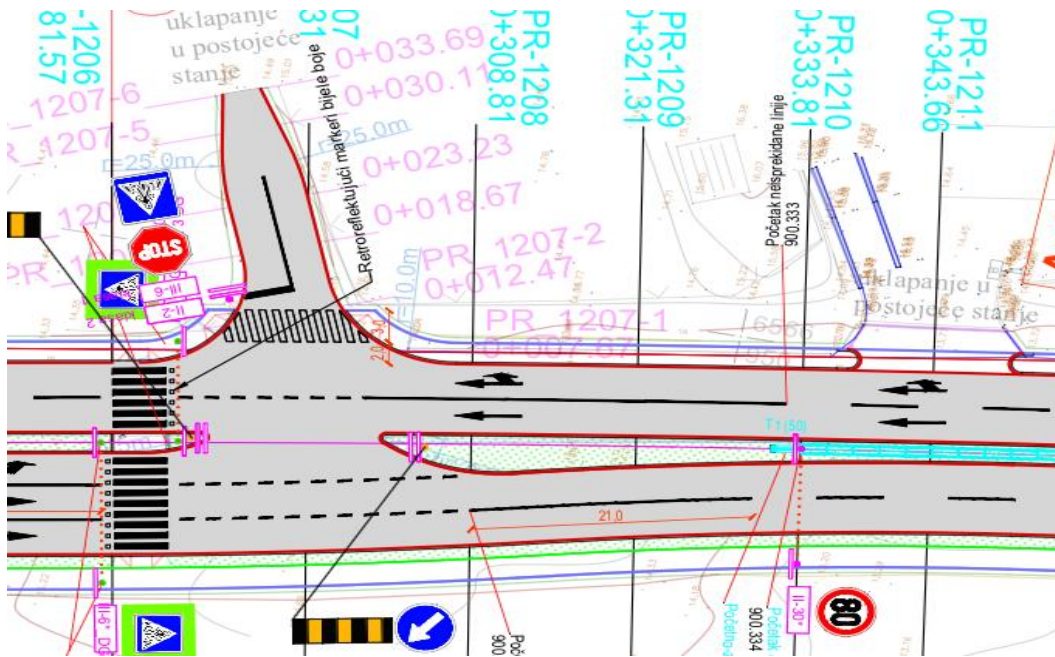
Figure 9.2: Proposed uncontrolled pedestrian crossing over multiple traffic lanes

The road safety audit report completed for the Tivat to Jaz Beach Road raised concerns about the gap in the median which will permit left turn movements across the project road. In addition, a proposed uncontrolled pedestrian crossing at this site location across multiple lanes of traffic as shown in the drawing extract in figure 9.2 provides a challenging and unsafe environment for pedestrians to cross. The survey has therefore counted pedestrian movements at the location for 4 days from 0600 – 1800hrs on
