INDEPENDENT ENGINEER SUPERVISION OF WORKS

WEEKLY REPORT CW 04

Contract number: 8854

WEEKLY REPORT

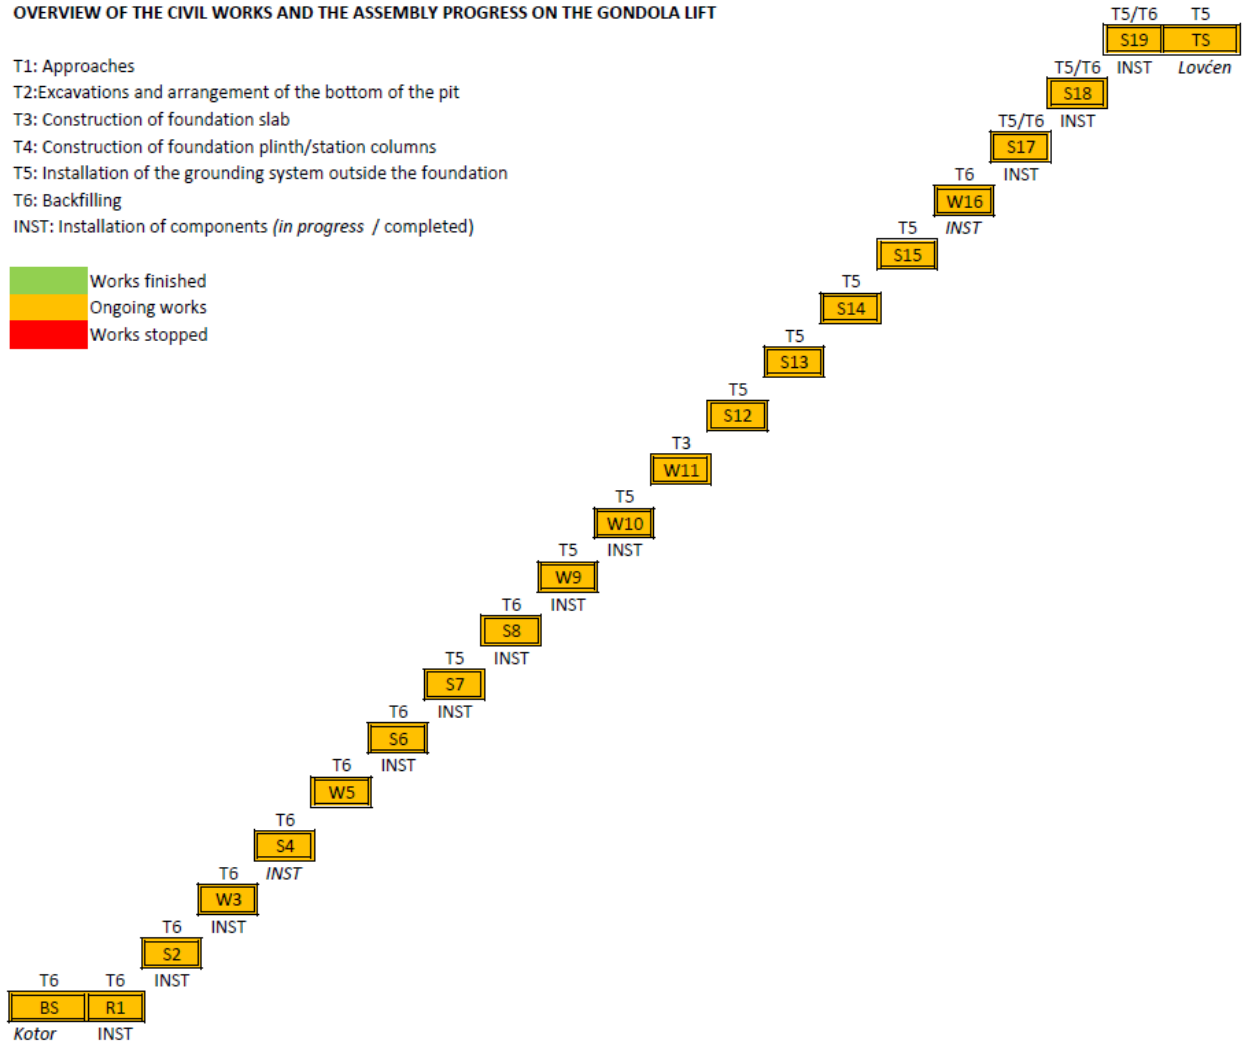
OVERVIEW OF THE CIVIL WORKS AND THE ASSEMBLY PROGRESS ON THE GONDOLA LIFT

- T1: Approaches
- T2: Excavations and arrangement of the bottom of the pit
- T3: Construction of foundation slab
- T4: Construction of foundation plinth/station columns
- T5: Installation of the grounding system outside the foundation
- T6: Backfilling
- INST: Installation of components (*in progress / completed*)

- Works finished
- Ongoing works
- Works stopped
