RAPID BIODIVERSITY ASSESSMENT

RECONSTRUCTION OF THE MAIN ROAD M-2 SECTION ROZAJE - SPIJANI

November, 2019.

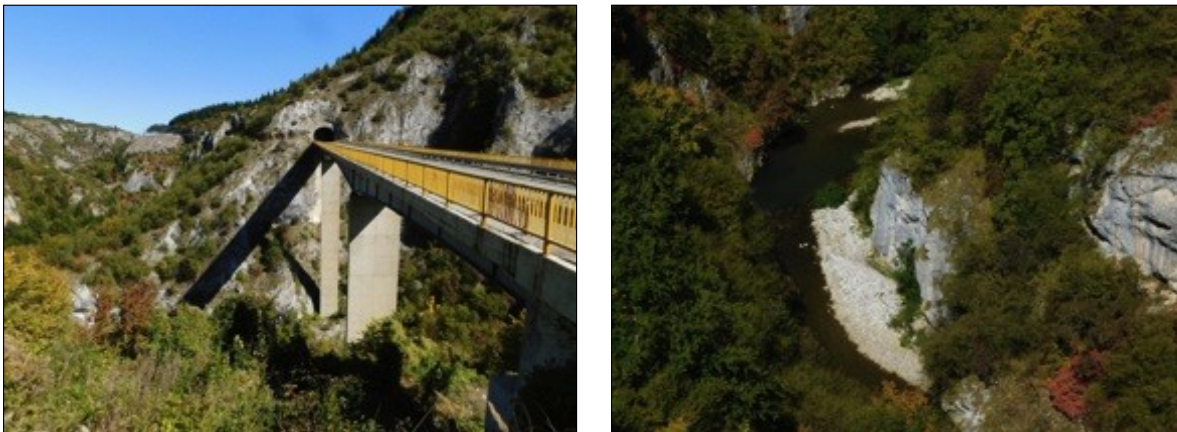
Figure 6. Selected location 5 –survey of amphibians and reptiles – The second bridge at the Ibar river. Bridge (left) and the Ibar river in the project area of influence (right)

Location 5, 42°51'45.41"N 20°13'4.41"E represents the location of the large bridge on the Ibar River (Figure 14 and Figure 15). Altitude of this section is 982 m asl. The Ibar River runs just under this bridge. Just as it was the case with the abovementioned locations in the upper course of the river, this section is also full of rapids which are populated by Danube barbel and common barbel (information provided by the Fishing Association Rozaje). This location is also highly critical in terms of fish fauna, and since impact caused by reconstruction will be rather prominent, it is necessary to implement protective measures aimed at protecting Black Sea Salmon.

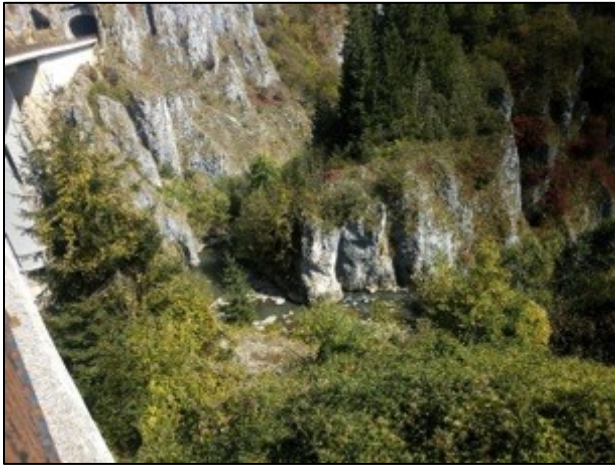
Figure 7. Location 2

Location 2, 42°51'12.20"N 20°12'15.29"E represents the location of bridge before the first tunnel and it is located at the altitude of 1003 m asl (Figure 6 and Figure 7). The bridge is located right along the Ibar River. The entire riverbed is located in the project Aol. The water is clear, and it is characterised by torrential flow. This part of the river is populated by Danube barbel and common barbel. The abovementioned information was confirmed by the Fishing Association Rozaje. It is necessary to protect the river with a retaining wall.

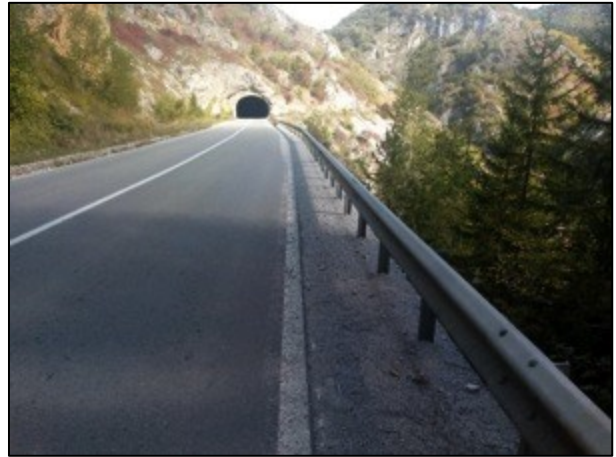
Figure 10. Location 4

Location 4, 42°51'26.88"N 20°12'37.88"E represents the road section which stretches from the second up to the third tunnel (Rozaje-Spiljani direction), and it is known by the name “Belocrkvansko vrelo” (Figure 10, Figure 11, Figure 12, Figure 13). This section is located at the altitude of 987 m asl. The riverbed is very close to the road and impact which will be caused by reconstruction is going to be rather high, taking into account that this entire section of the riverbed is located in the project Aol. This section of the river is full of whirlpools and rapids, which are populated by Danube barbel and common barbel. Sampling at this location was carried out on 03rd October 2019, and low voltage generator was used for this purpose. Length of the transect was around 300 m. Presence of the abovementioned two species was confirmed.

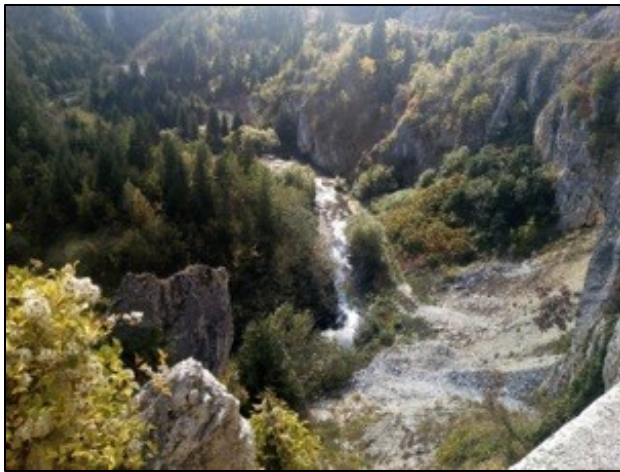
Figure 8. Location 3

Location 3, 42°51'23.27"N 20°12'26.39"E represents a 100m long road section before the second tunnel (Rozaje-Spiljani direction) (Figure 8 and Figure 9). It is located at the altitude of 1012 m asl. Just as it was the case with the location 2, location 3 represents the road section which is located just along the Ibra riverbed.

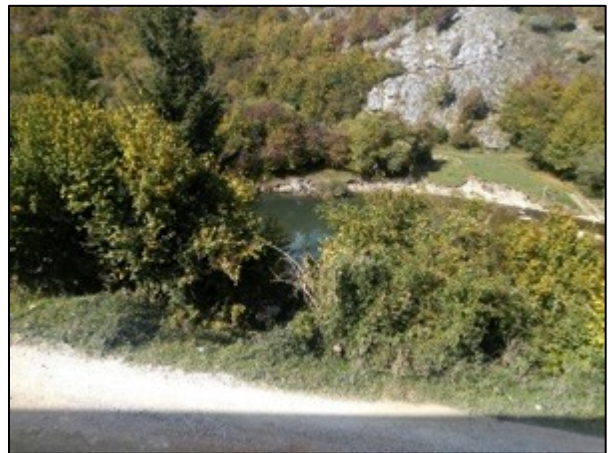
Figure 16. Location 6

Location 6 42°54'6.70"N 20°19'4.70"E represents the border crossing Dracenovac (Figure 16 and Figure 17). This section is located at the altitude of 826 m asl, and it is situated in vicinity of the lower course of the Ibar River. Sampling was carried out at this location, and the transect included a 300 m long upstream section. It is planned to widen the road along both sides of the road, whereby each side would be widened in the length of 300 m. Sampling was carried out on 04th October 2019. The transect included a 300m long upstream section. Presence of the following species was determined: huchen, Mediterranean barbel, common nase, chub and grayling. The specimens which were caught we photographed and returned to the ecosystem.

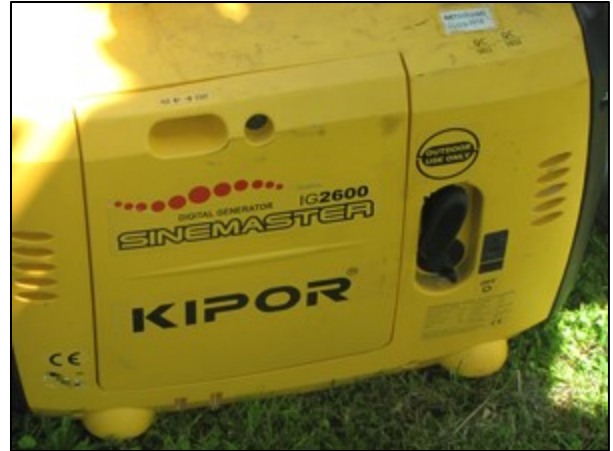
Sampling was carried out by the means of low voltage generator (Figure 24). The specimens were photographed, species of each specimen was defined, after which they were returned to the river.

Figure 24. Power generator

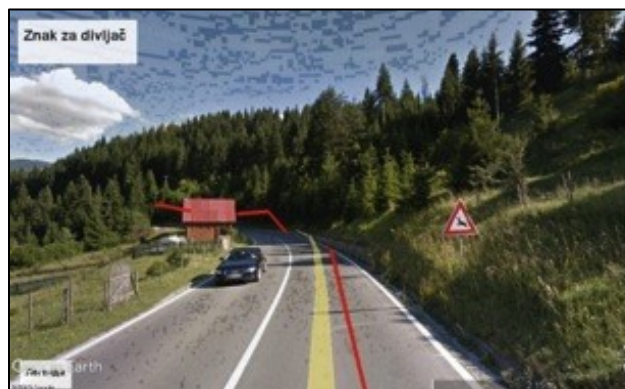
Figure 6. Wildlife warning sign from the direction of Rozaje

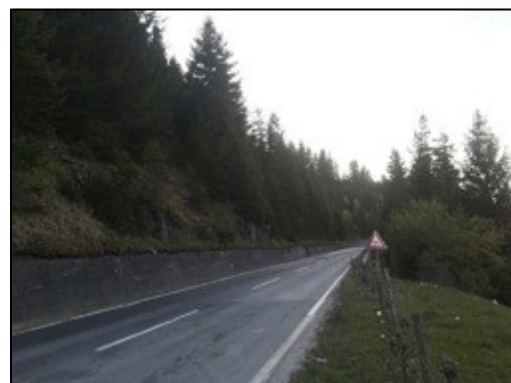
Figure 7 Wildlife warning sign from the direction of Spiljani

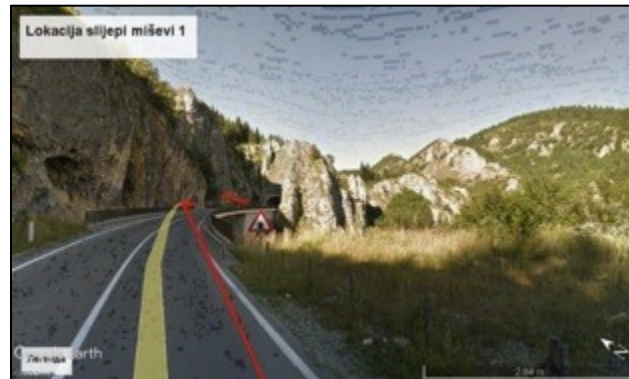
Figure 8. Location bats

A transect walk to the coordinate 42 51 21 23 N 20. 12 29 19 E (through the tunnel) was carried out, using the 240 X Patterson ultrasonic detector. The presence of bats was not detected on the section. Also, their shelters were not found (tunnel, below the viaduct).

No traces of other mammals were found.

Conclusion: The location has been assessed as irrelevant in terms of the bat's presence. Reconstruction of this road section will have a negligible impact on bats and mammal's fauna in general.

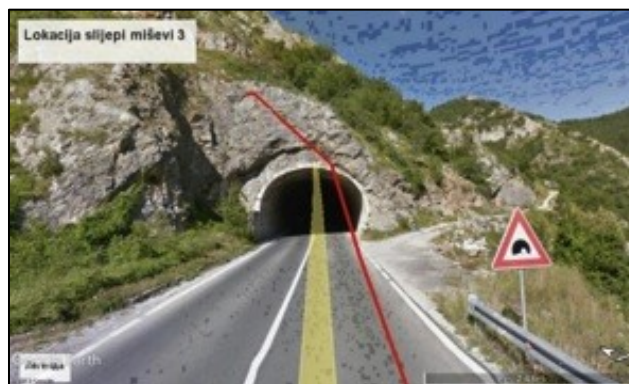
Figure 9. Location bats

The voices of bats were not detected at the location. The presence of bats in a potential shelter (tunnel) was not detected on the section. No traces of other mammals were found.

Conclusion: The location has been assessed as irrelevant in terms of the bat's presence. Reconstruction of this road section will have a negligible impact on bats and mammal's fauna in general.

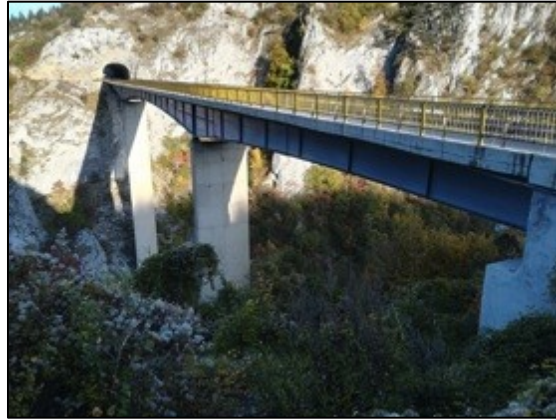
Figure 10 Location of bats 5

The presence of bats was not detected by the ultrasonic detector. Traces of fox was found (faeces).

Conclusion: The location has been assessed as irrelevant in terms of the bat's presence. Reconstruction of this road section will have a negligible impact on bats and mammal's fauna in general.

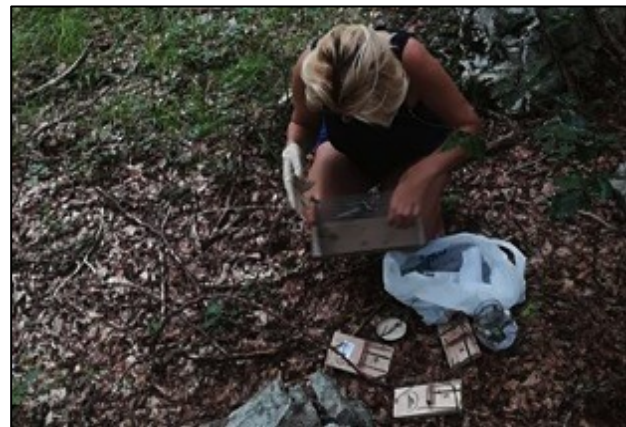
Figure 12. Setting traps

In the spruce - beech forest, at site 42 52 5 01 20 13 47 95, traps for small mammals and a photo traps were installed. An ultrasonic detector was used to detect bats. A looking for traces of mammal's presence was carried out, as well as a looking for their shelters.

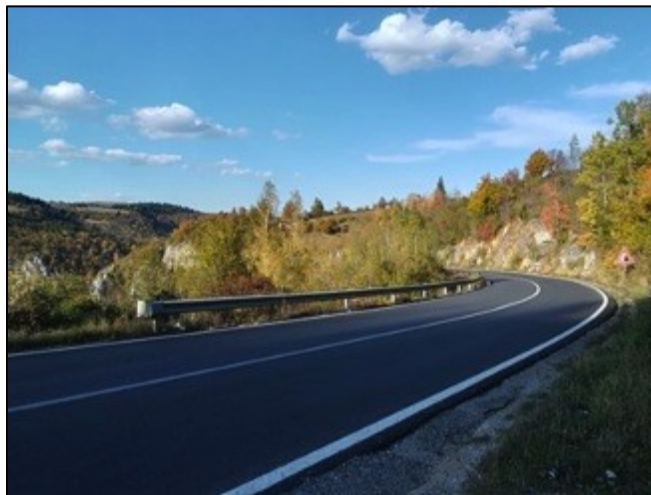
Figure 14. Location 8

At this location, a trace of mammal's presence was detected: fox, marten, Long-tailed field mouse (faeces, holes...). Sometimes, the local population notice a fox. At this location, the presence of bats was not detected by the ultrasonic detector.

Conclusion: The location has been assessed as suitable habitat for mammals.

Reconstruction of this road section will have a negligible impact on mammal fauna.

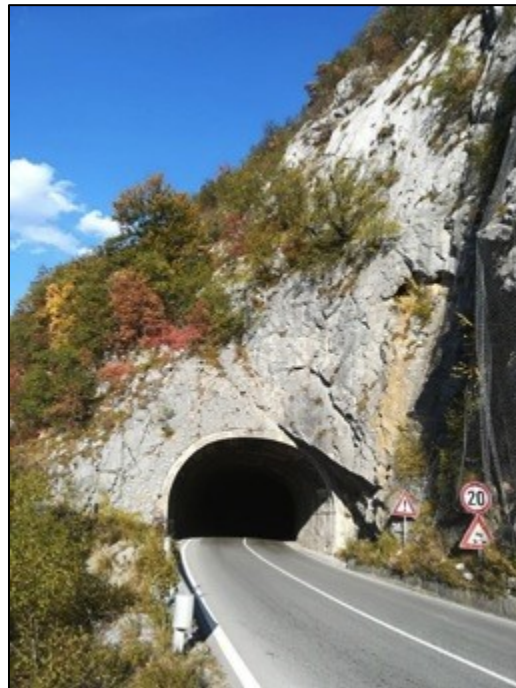
Figure 16. Location 9

The voices of bats were not recorded. Their habitats also have not been found.

No traces of other mammals were found.

Conclusion: Reconstruction of this road section will have a negligible impact on mammals' fauna.

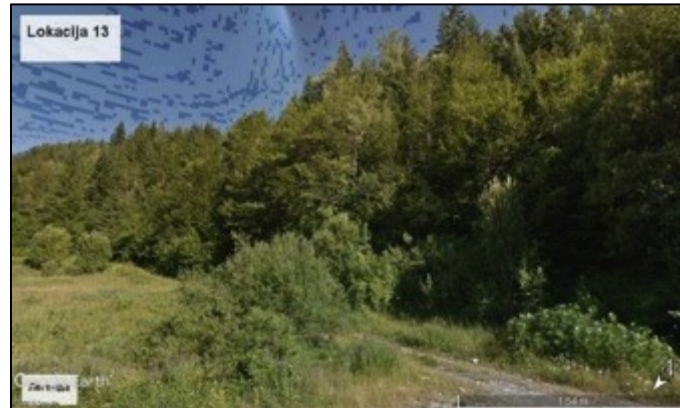
Figure 19. Location 13

Traps and photo trap were placed on the location. In the photo trap, it has been recorded two individuals of the species **Sus scrofa** - wild boar.

There was no catch in the traps. Traces of the mammal's presence were found: feces of fox, feces of marten, holes from Long-tailed field mice. The presence of bats was not detected by the ultrasonic detector.

Conclusion: The location is a suitable habitat for mammals. This area is under anthropogenic influence (cutting of tree). Reconstruction of this road section will have a negligible impact on mammals' fauna.

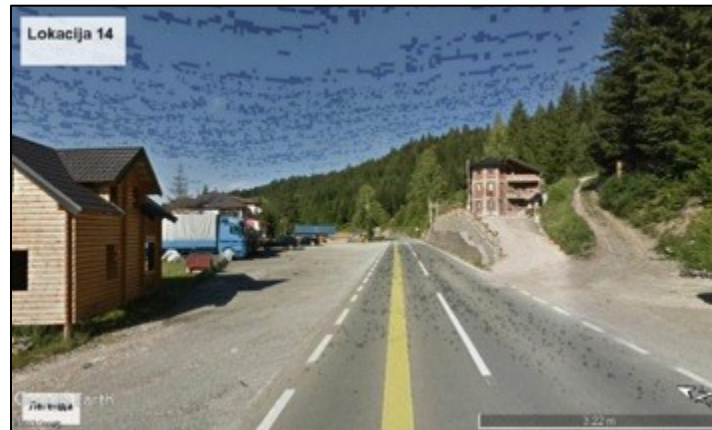
Figure 21. Location 14

The presence of bats was not detected by the ultrasonic detector. In the forest, it was found traces of bear presence (peeled bark of tree), as well as holes from mice.

Conclusion: The location has been assessed as a suitable habitat for mammals (far away from the road). This area is under anthropogenic influence, especially parts along the road. Reconstruction of this road section will have a negligible impact on mammals' fauna.

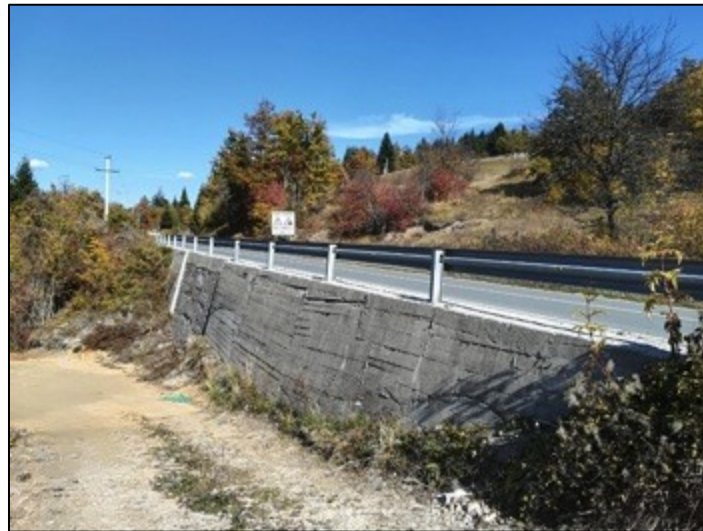
Locations 16 and 17

Figure 23. The main passageway for mammals Location 16

Conclusion: The location is assessed as an important habitat/movement corridor for mammals. With the application of appropriate measures, the existing condition can be improved during the reconstruction in terms of reducing the collision of mammals with vehicles.

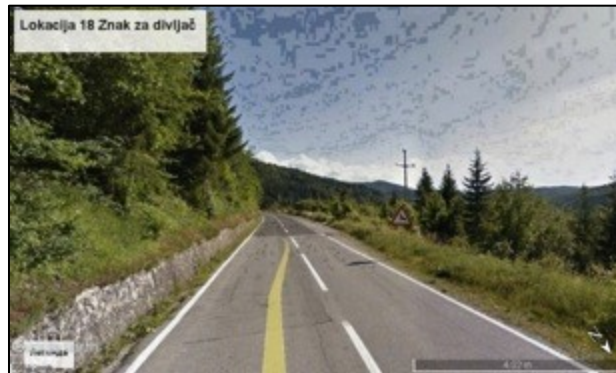
Location 18

Figure 26. Wildlife warning sign

At this part of the road begins the main passage/ movement corridor of mammals (from the direction of Spiljani).

No traces of mammals were found. The presence of bats was not detected by the ultrasonic detector.

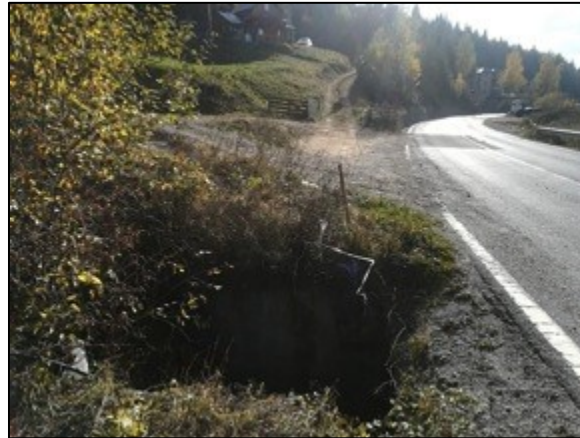
Figure 33. Passage 1

There is a passage under the road in the section which is defined by coordinates 42. 53 114 50 N 20 16 21 60 E, and according to information provided by members of the local community, this passage is used by mammals for crossing from the left to the right side of the road.

- All the existing passages which are located under bridges and viaducts along the road section should be cleaned, and widened where possible;
- According to information about frequent roadkill's, which was provided by the Hunting Association "Hajla", and additionally confirmed by the members of the local community and media coverage, it is necessary to ensure conditions for safe passage of animals in the section of the main corridor/ passage for mammals which stretches from 42.51 16 34 N 20. 11 27 08 E to 42. 53 27 14 N 20. 16 27 37.

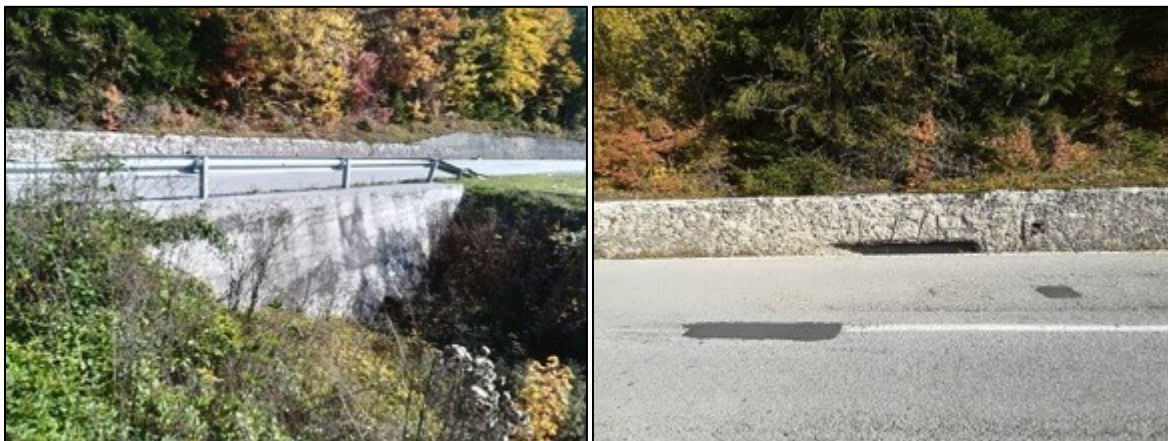
Another animal passage is located slightly further from the abovementioned passage, at the point between 42. 53 17 87 N 20. 16 23 34 E, whereby a small creek runs through this passage.

Figure 34. Passage 2, view from both sides of the road

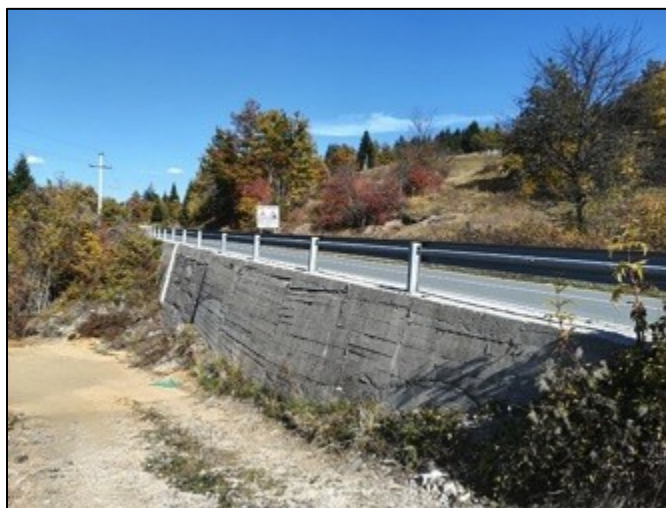
Representatives of the local Hunting Association suggest that, if possible, a new, passage 3 (diameter of culvert 1,5m) should be built at the location defined by coordinates 42 53 22 44 N 20 16 24 71E, since they deem that would be the best solution.

Figure 35. Main passage 3

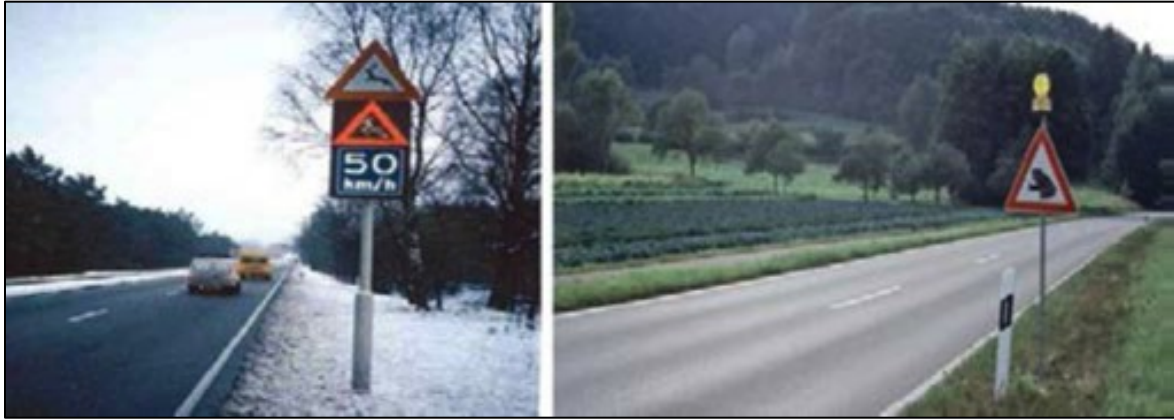
Examples of passages

Example of crossing on the road surface: (a) for animals; (b) for amphibians

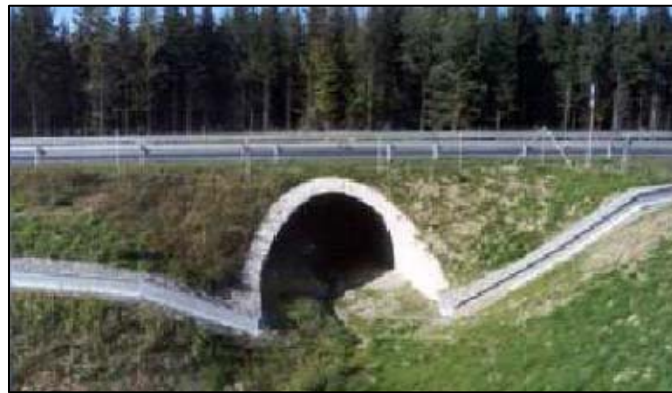
Arch culvert with fence for large mammals and lipped wall for amphibians (FHWA/US DOT, 2002)
