## Annex I) Habitat Survey Report

## **1. Introduction**

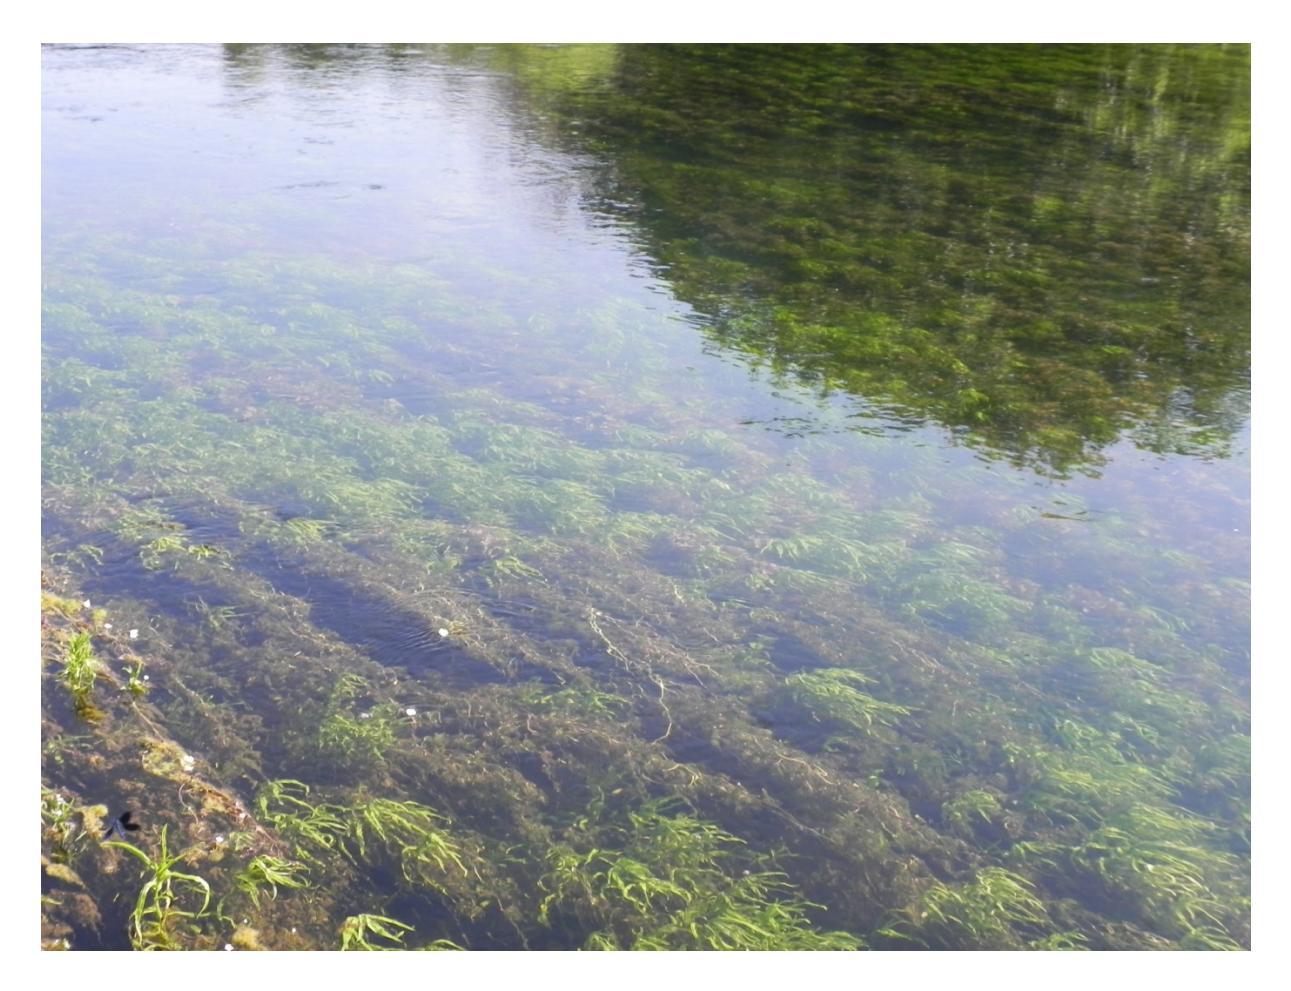
Picture 1. Water courses of plain to montane levels with the *Ranunculion fluitantis* and *Callitricho-Batrachion* (Komanski bridge)

**3260** - Water courses of plain to montane levels with the *Ranunculion fluitantis* and *Callitricho-Batrachion* – This type of habitat is presented in Sitnica River (close to the Komanski most bridge) and is presented with submerged or floating vegetation of the *Callitricho-Batrachion* (low water level or dry during summer) with domination of *Ranunculus trichophyllus*. This community is represented with different plant species with different abundance and cover (according to the metodology of Braun-Blanquet 1964): *Ranunculus trichophyllus* 3, *Myosotis scorpioides* 2, *Fontinalis antipyretica* 1, *Mentha aquatica* 1, *Potamogeton lucens* +, *Alisma lanceolatum* +, etc.

High sensitive habitat type. This type of habitat will be under direct impact in the area of Komanski most bridge (reconstruction of old bridge and build of new one) and also under indirect impacts along the river (mining the adjacent hill Zelenika, earthworks and material transfer). Impacts could resulted with changes in water conditions (hydrological impacts), changes in surface and ground water conditions, habitat pollution including deposition and run-off, changing the direction of surface run-off due to earthworks. It is considered as high (significant) impact. Effect of the impact will resulted with the loss of small percentage of this habitat. Also, it will affect aquatic species (surface waters).

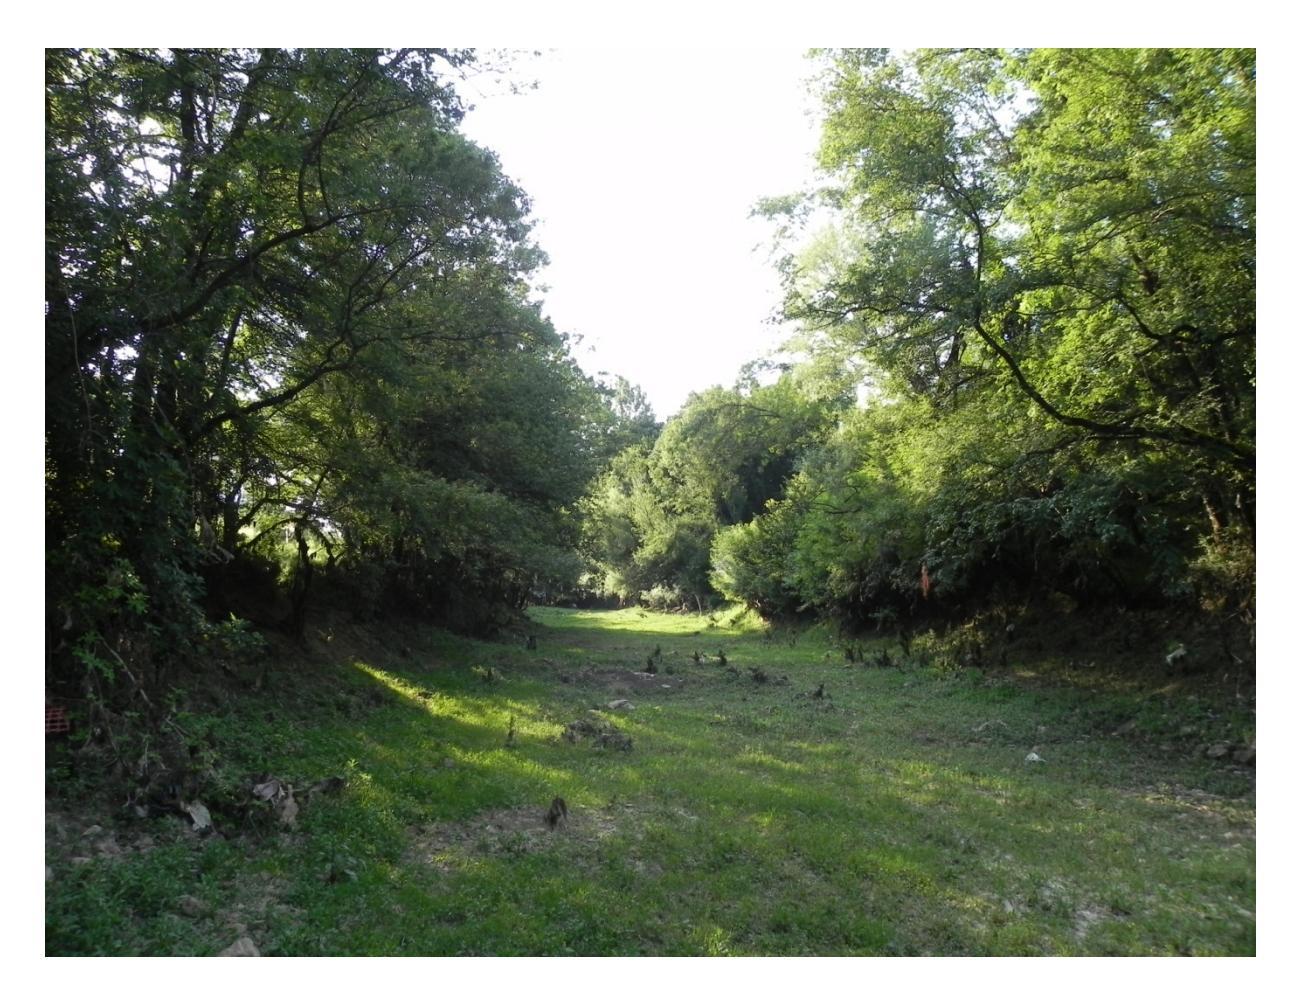
Picture 2. 92Ao - Salix alba and Populus alba galleries (Sušica River)

**92Ao** - *Salix alba* and *Populus alba* galleries - This type of habitat is presented along to the Matica, Sušica, Crkovnica Rivers, Niski potok stream and along drainage channels. This type of habitat in the Project Study Area is represented with two type of plant communities, the one dominated by *Fraxinus angustifolia* (*Fraxinus angustifolia*) and the other dominated by *Salix alba* (fragments of *Salicetum albae*). Phytocoenolofical relevé of the community with domination *F. angustifolia* was taken in the Matica River (Radulovići) and is represented with different plant species with different abundance and cover (according to the metodology of Braun-Blanquet 1964): *Fraxinus angustifolia* 4, *Salix alba* 2, *Ulmus glabra* 1, *Quercus robur* +, *Ficus carica* +, *Morus alba* +; shrubs: *Rubus idaeus* 1, *Cornus sanguinea* 1, *Clematis viticela* 1, *Hedera helix* 1, and herbs: *Lysimachia nummularia* 3, *Agrostis alba* 2, *Iris pseudacorus* 2, *Cardaminae mathiolii* 1, *Cyperus sp.* 1, *Lychnis flos cuculi* 1, *Mentha aquatica* +, *Veronica anagallis-aquatica* +, *Aristolochia rotunda* +, *Alisma plantago-aquatica* +, *Rumex conglomeratus* +, *Asparagus tenuifolius* +, *Galium palustre* +, *Carex otrubae* +, *Plantago intermedia* +, *Picris hieracioides* +.

High sensitive habitat type, particularly in the zone of the Matica bridge and along the Matica River. Also, riparian forest are the most representative along Sušica River downstream of the bridge. This type of habitat will be under direct impact (reconstruction old bridge and build of new bridge in the area of Matica and Sušica Rivers). Also, the Project currently proposes to set up construction site along the route, of which one will be located in the immediate proximity to Matica-Sitnica River (Construction site 2 – intersection to Cafa and Baloči;). Works at these site will include clearance of vegetation and would directly impact on a this type of habitat. Further loss of this habitat will result from clearance works along the course of the Matica-Sitnica, from the current bridge to the Komanski bridge, with the river banks near the latter particularly affected. Field elm and narrow-leafed ash trees are also proposed to be felled near the proposed Sušica, Matica, Komanski Bridges. These works are considered to have a high level of impact (significant)

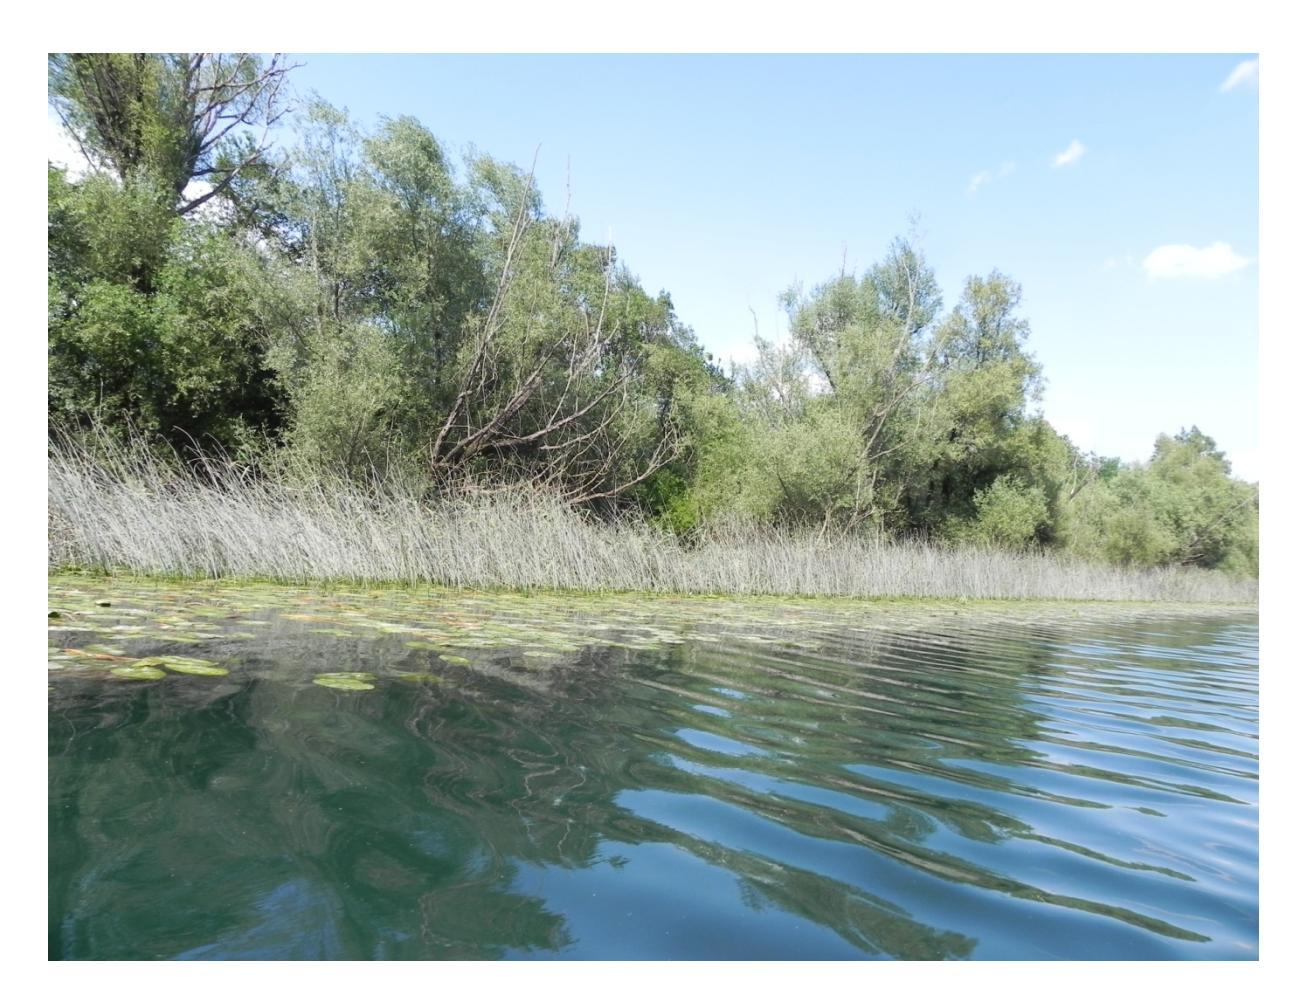
Picture 3. Phragmites and Scirpus beds along Matica River

**C3.21** - *Phragmites* beds - This type of habitat in the Project Study Area is presented only on the right (42 27 768N 019 10 598E) and left banks of the Matica River like line type of habitat. This community is quantitativy poor and represented with: *Phragmites australis* 5 *and Scirpus lacustris* 1.

**C3.22** - *Scirpus lacustris* beds - This type of habitat in the Project Study Area is presented along to the Matica River (42 27 429N 019 11 038E) and completely dominated by *Scirpus lacustris* (*Scirpetum lacustri*).

*Phragmites* and *Scirpus* beds are recorded along Matica River only. Sensitive habitats because support some aquatic species (fishes, amphibians...). These types of habitats will be under direct impact (reconstruction of old bridge and build new one) and also under indirect impacts along the whole river (mining the adjacent hill Zelenika, construction work

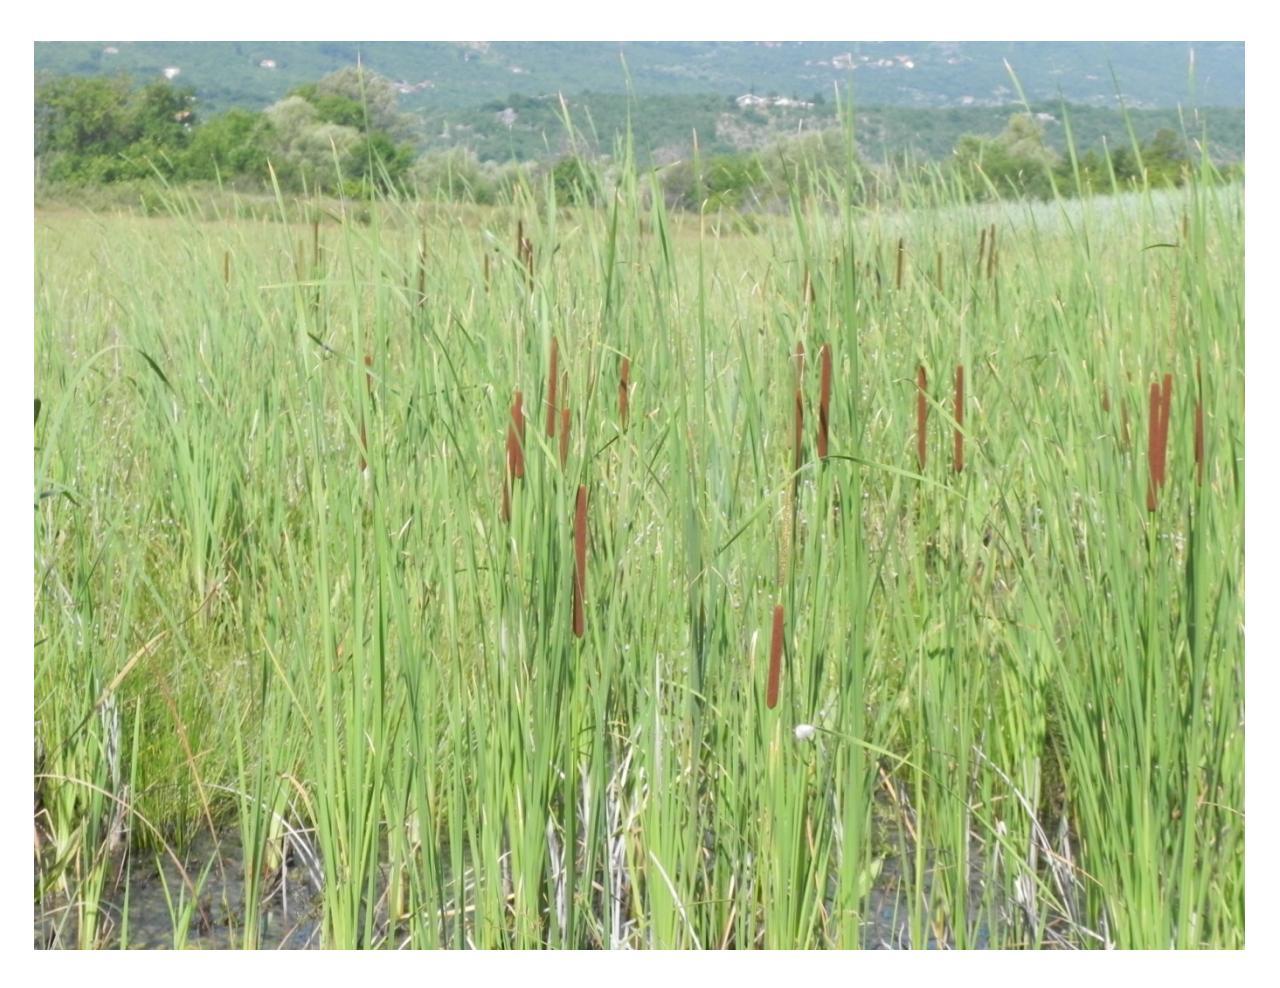
Picture 4. Swampy meadows with Typha beds on the Slivnice

**D5.13** - **Reedmace** (*Typha*) beds normally without free-standing water - This type of habitat in the Project Study Area is presented on the left side of the road PG – DG, about 250 m long and about 150 m wide, from coordinates 42 27 886N 019 10 520N to 42 27 740N 019 10 556E. This community is represented with different plant species with different abundance and cover (metodology of Braun-Blanquet 1964): *Typha angustifolia* 5, *Eleocharis palustris* 1, *Juncus tenuis* 1, *Alisma plantago aquatica* +, *Lythrum salicaria* +, *Gratiola officinalis* +.

The area of reed *Phragmites beds* and reedmace *Typha* beds are located in Slivnice. This type of habitat support many animal species (amphibians, reptiles, birds, small mammals and bats).

Swampy meadows characterised by common reed *Phragmites australis* and by reedmace *Typa angustifolia*, a total surface of the habitat is around 128.000m<sup>2</sup>. Permanent loss due to implementation of the project is around 12000 m<sup>2</sup>. This type of habitat has high sensitivity on fragmentation as a habitat which support notable species (amphibians, reptiles, birds, bats, ...).

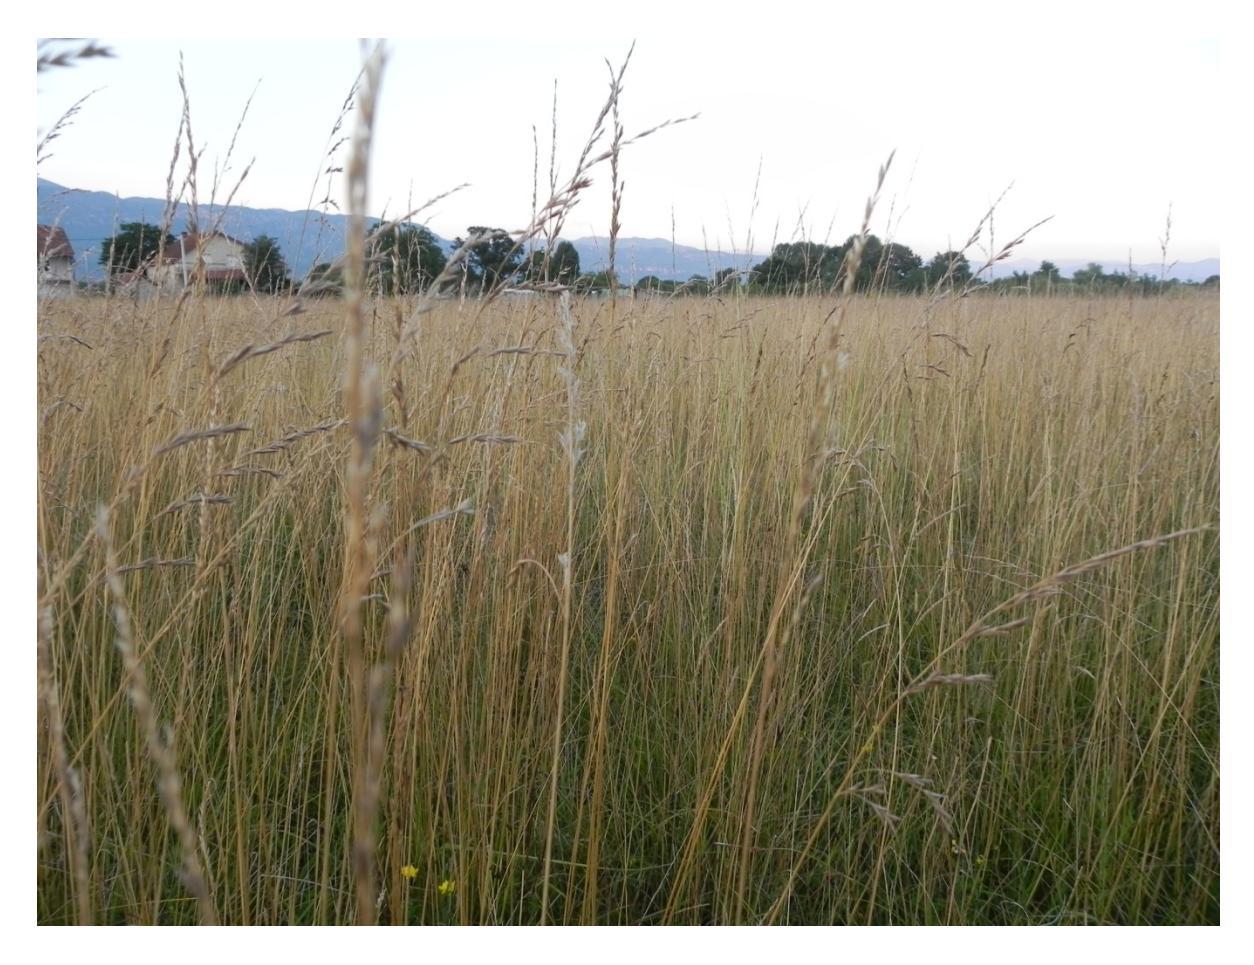
Picture 5. Meadow community with Festuca pratensis on the Ćurilac locality

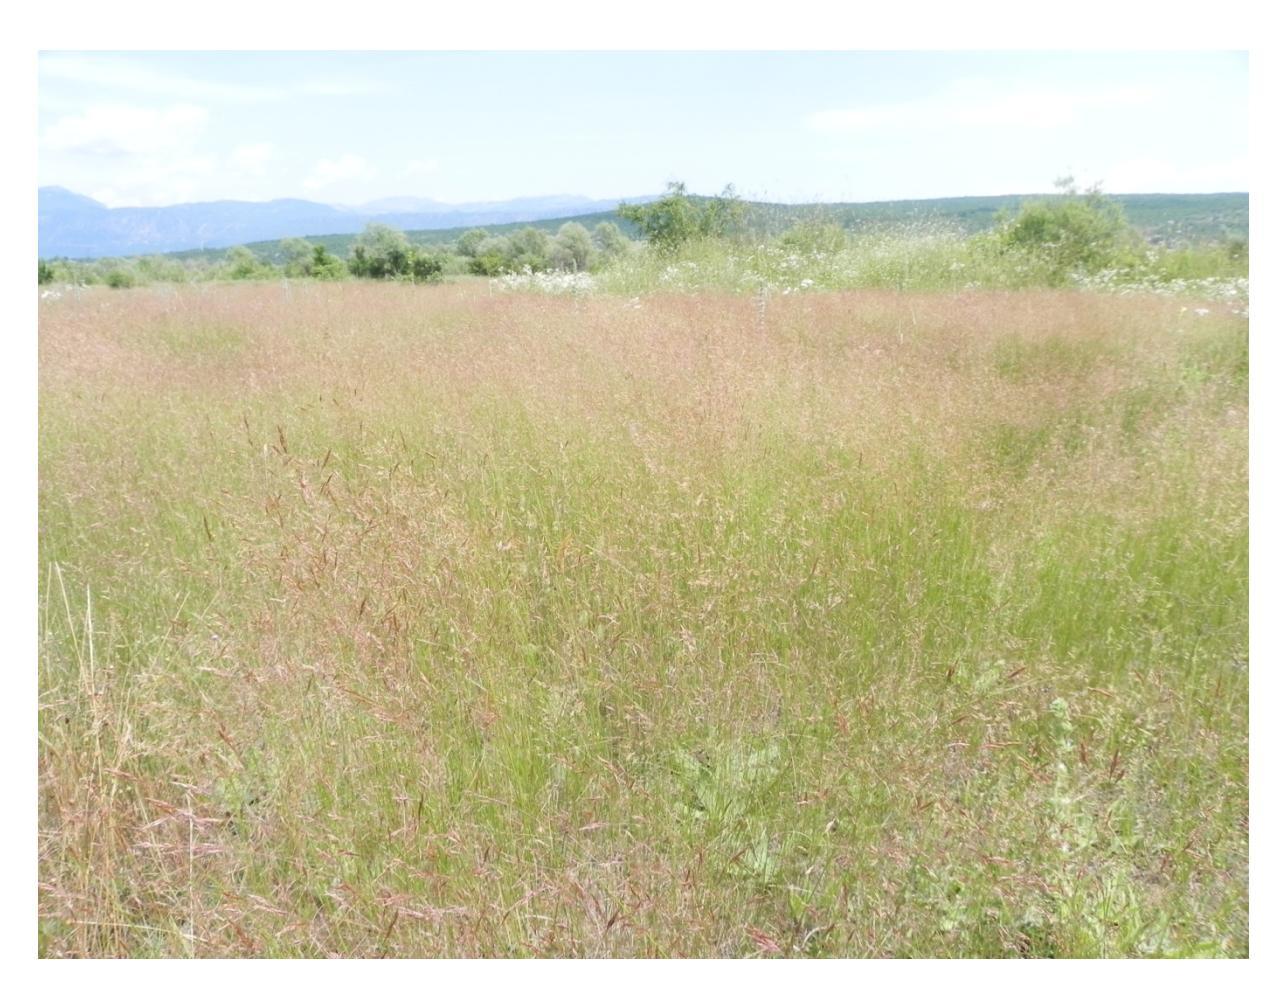
Picture 6. Wet meadow along to the road

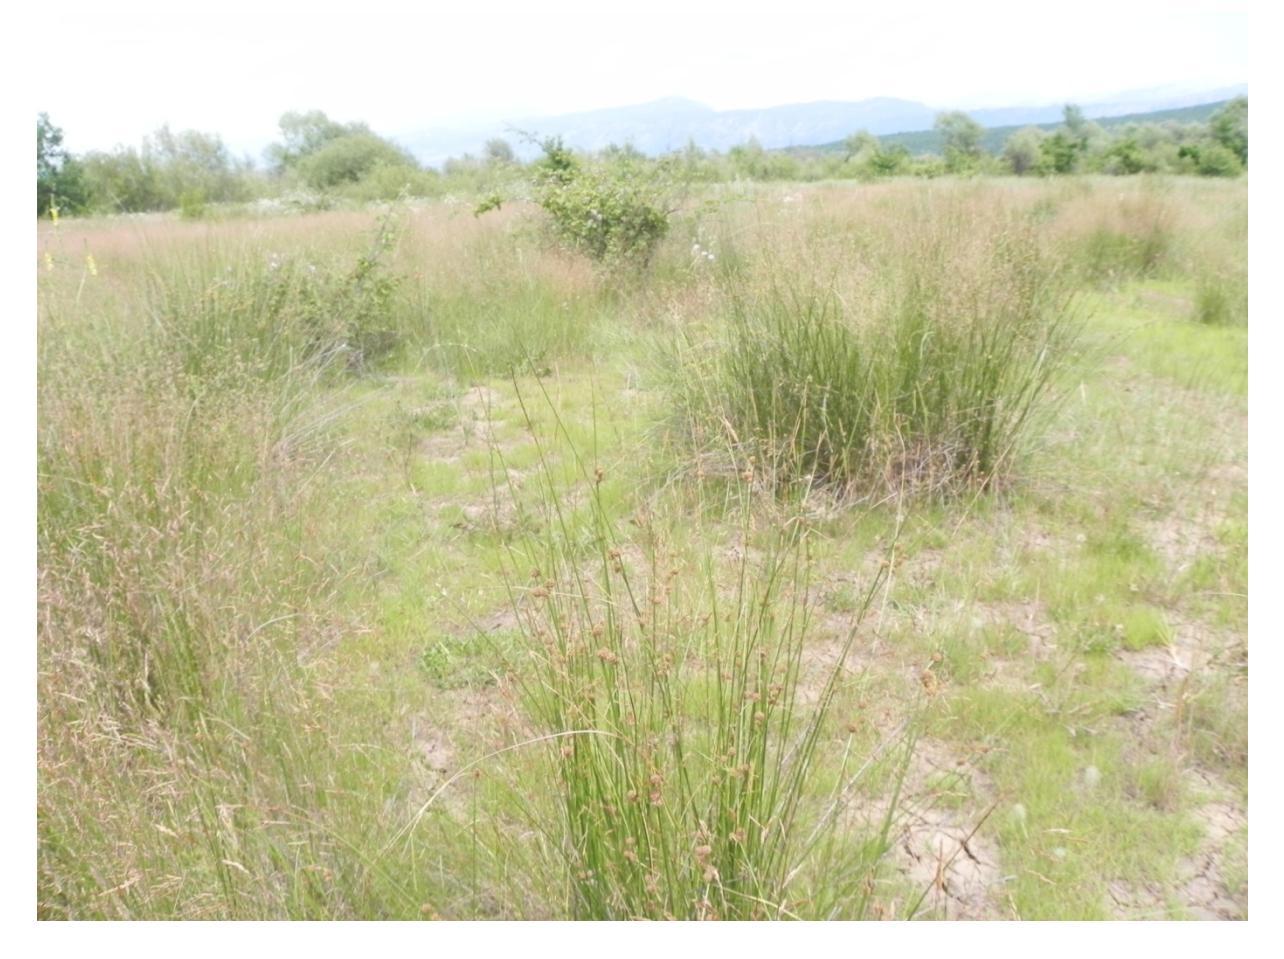
Picture 6. Fragment of the Holoschoenion vulgaris comm. on the Mareške bare

Flood swards and related communities are represented with mosaic of habitats on the left side of the road (locality Mareške bare) and the right side of the road (locality Slivnice below Lužnica hill). This swampy area is strongly degradeted on locality Mareške bare. On the locality Slivnice this mosaic of habitats are very representative (A)! Habitat cover is 170.000 m<sup>2</sup>
